Notification of Water Quality Monitoring Exceedance

Incident Report on Action/ Limit Level Exceedance

Reference No.:	IR20210522_M1_SS																																				
Project:	Contract No. SPW 07/2020 Environmental Team for Construction of Yuen Long Effluent Polishing Plant Stage 1																																				
Date:	2021/05/22																																				
Time: (hh:mm)	(Ebb Tide) M1: 10:47 (Impact Station) M2: M3:																																				
Action level / Limit level: (For Ebb Tide)		DO (mg/L)		Turbidity (NTU)		SS (mg/L)																															
		AL	LL	AL	LL	AL	LL																														
	M1	2.25	1.91	49.4	53.6	59	68																														
	M2	1.88	1.79	43.0	52.4	81	112																														
	M3	3.28	3.14	74.3	78.0	104	167																														
Measured level of exceeded parameter: (fill in / circle as appropriate)	M1	DO (AL / LL) : _____		M3	DO (AL / LL) : _____																																
		NTU (AL / LL) : _____			NTU (AL / LL) : _____																																
		SS (AL / LL) : <u>62</u>			SS (AL / LL) : _____																																
	M2	DO (AL / LL) : _____																																			
		NTU

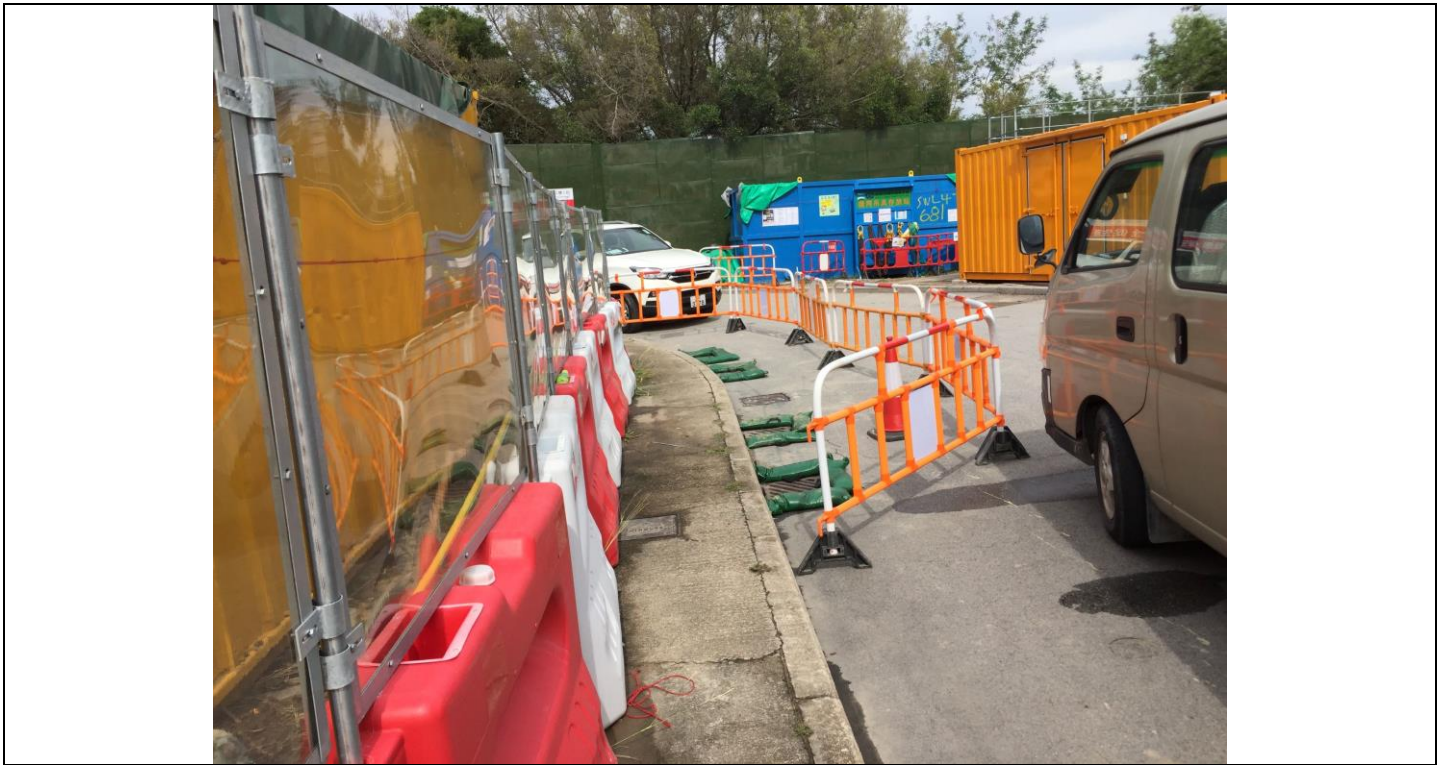
Date of site inspection: 25 May 2021
Gullies were banded by sand bags to prevent surface runoff.

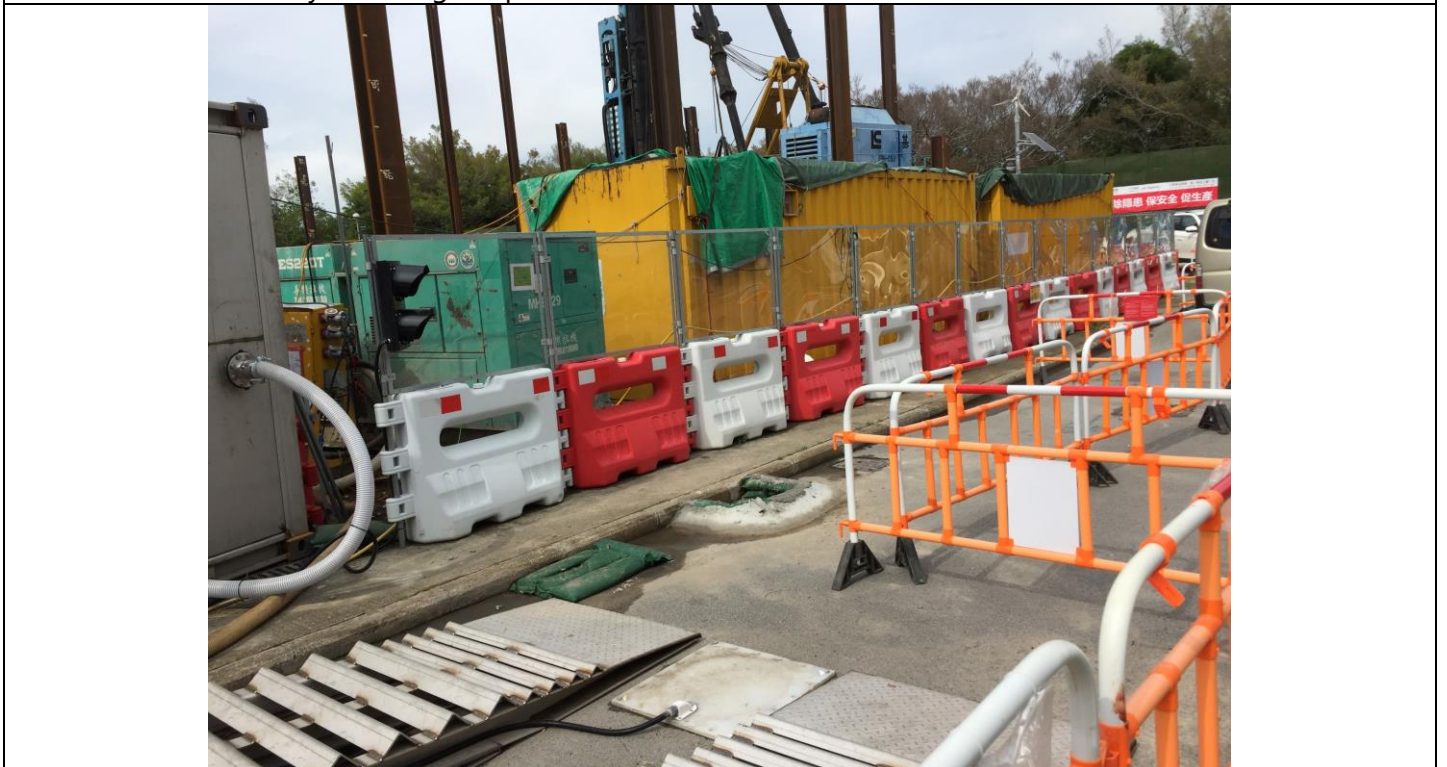
Date of site inspection: 25 May 2021
The surrounding of gullies near the construction site areas were temporarily sealed.

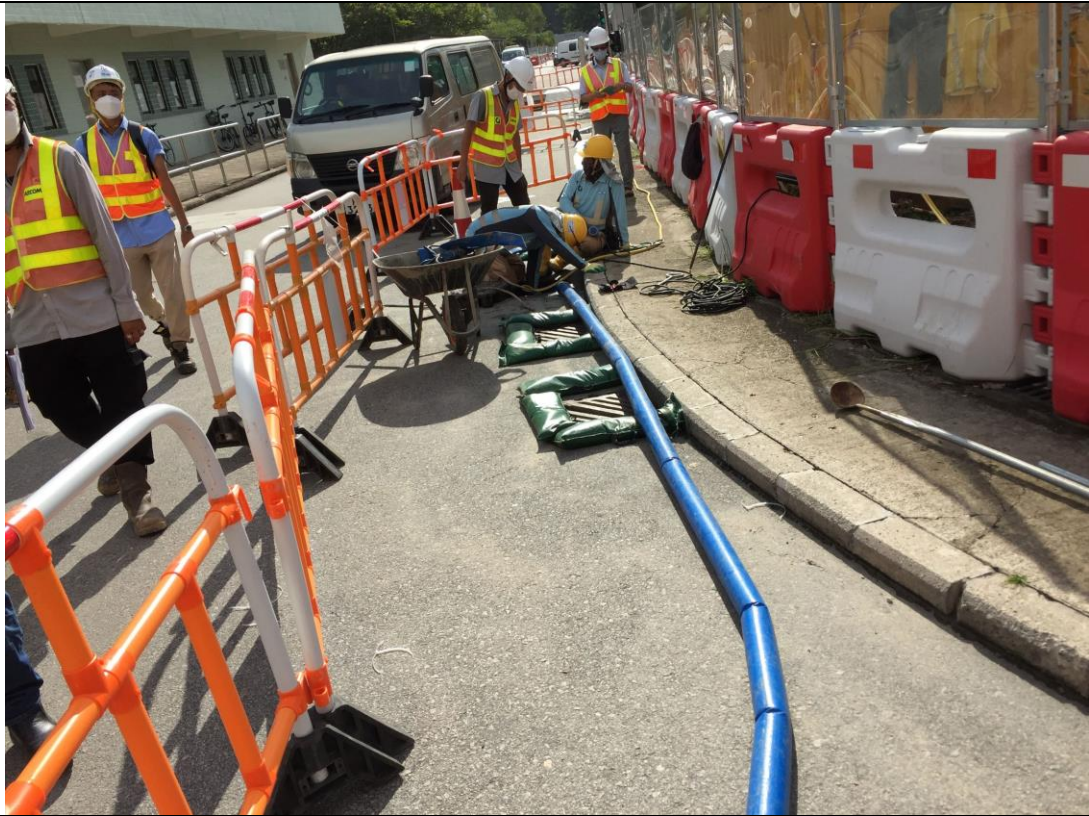
Date of site inspection: 25 May 2021

Manholes were maintained to remove the deposited silt after the rainstorm to prevent overflows.

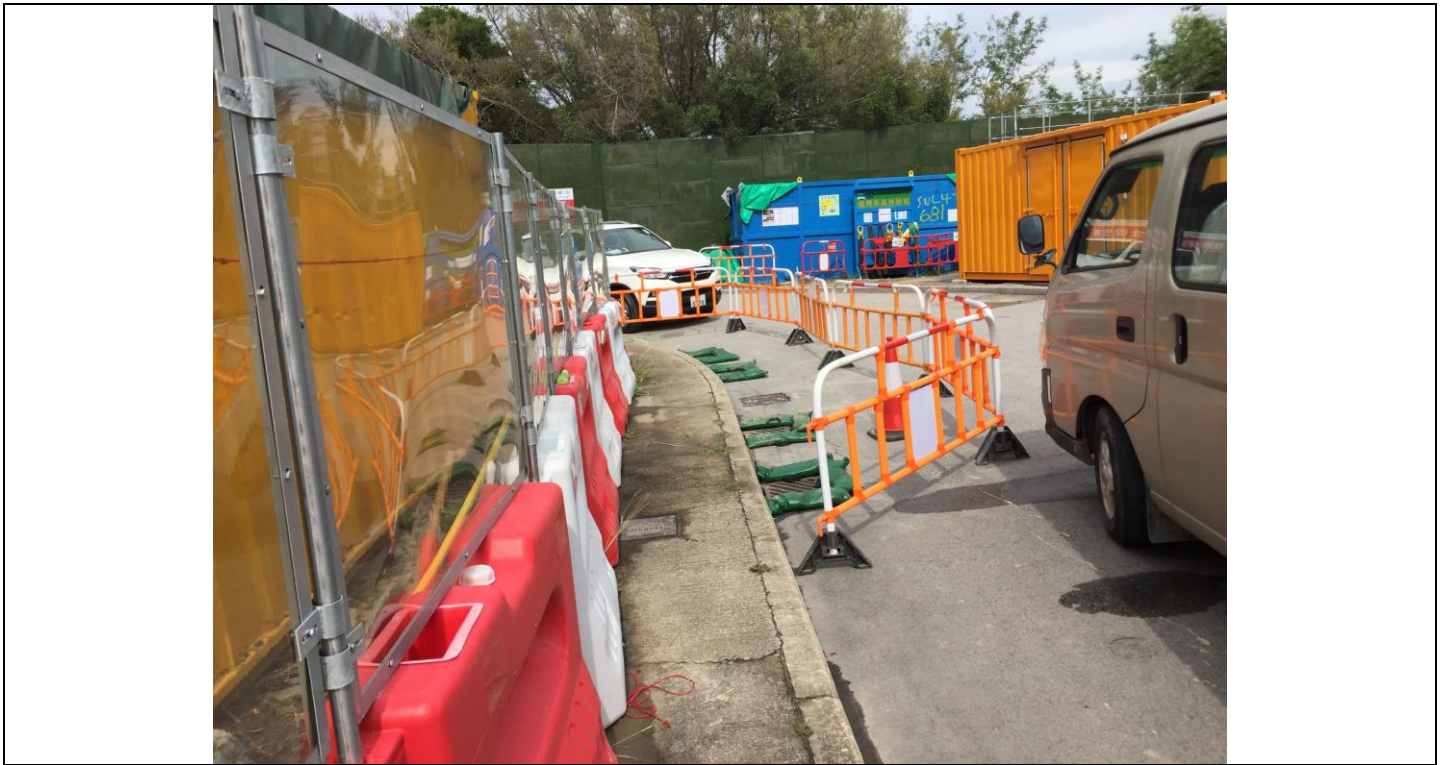
Date of site inspection: 25 May 2021
Gullies were bunded by sand bags to prevent surface runoff.

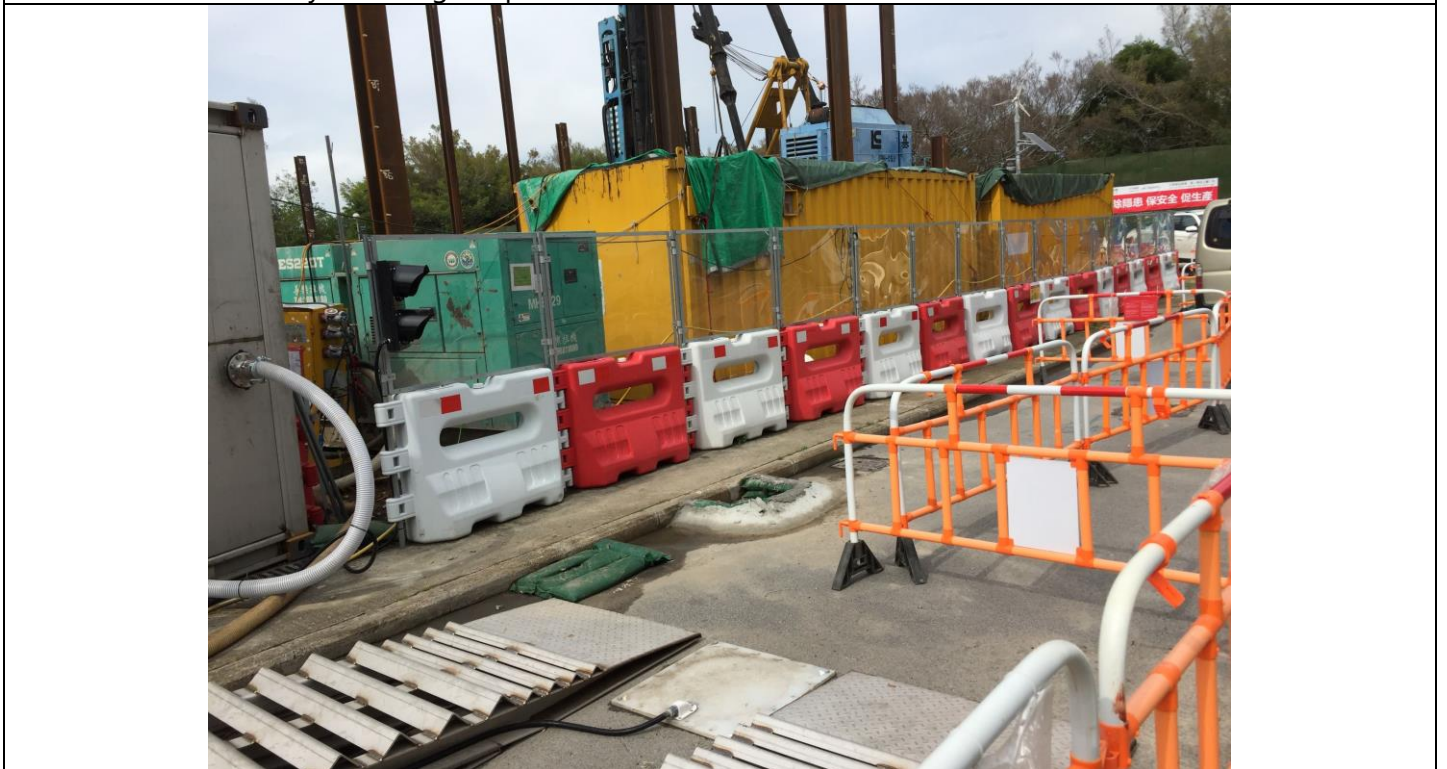
Date of site inspection: 25 May 2021
The surrounding of gullies near the construction site areas were temporarily sealed.

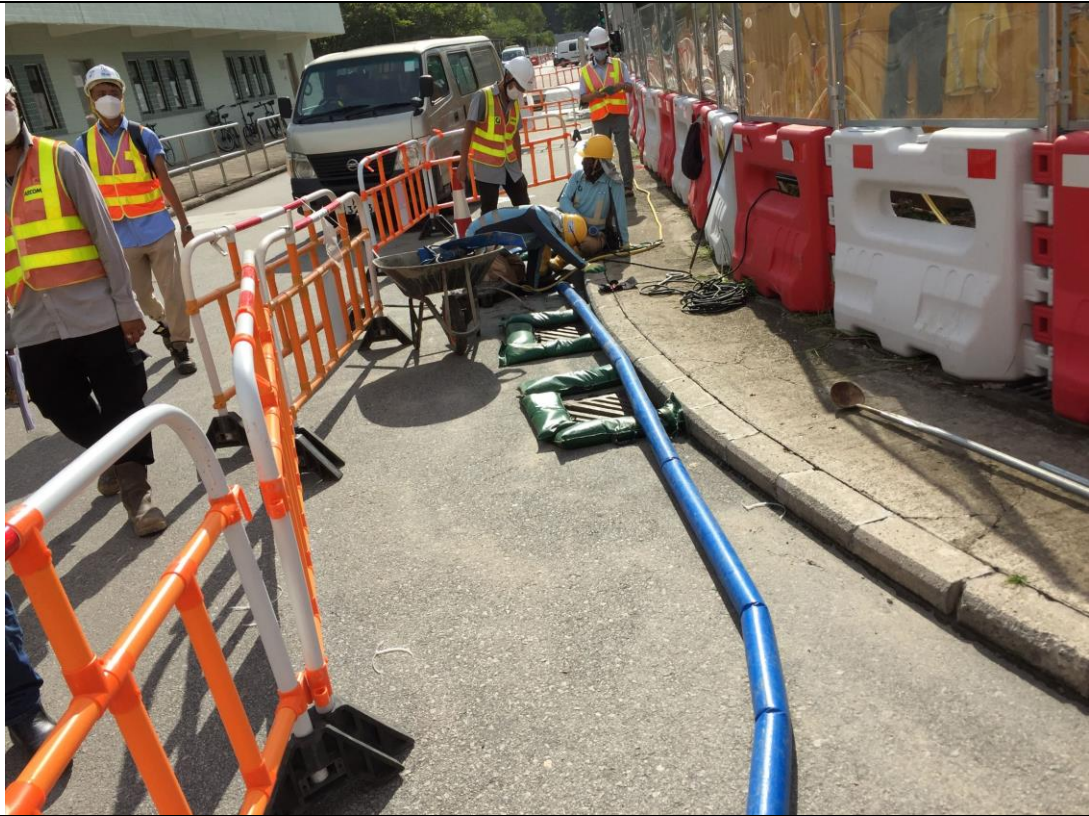
Date of site inspection: 25 May 2021

Manholes were maintained to remove the deposited silt after the rainstorm to prevent overflows.

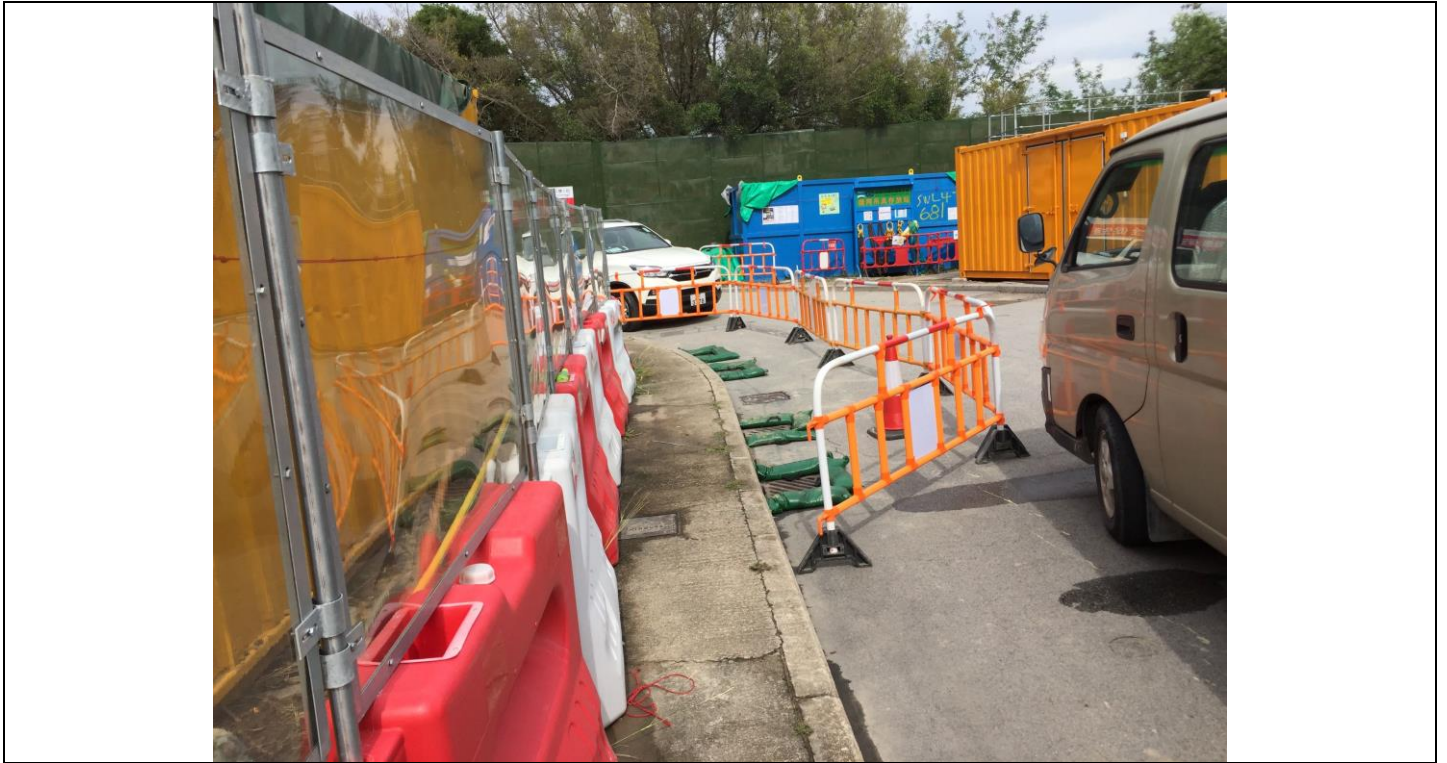
Date of site inspection: 25 May 2021
Gullies were banded by sand bags to prevent surface runoff.

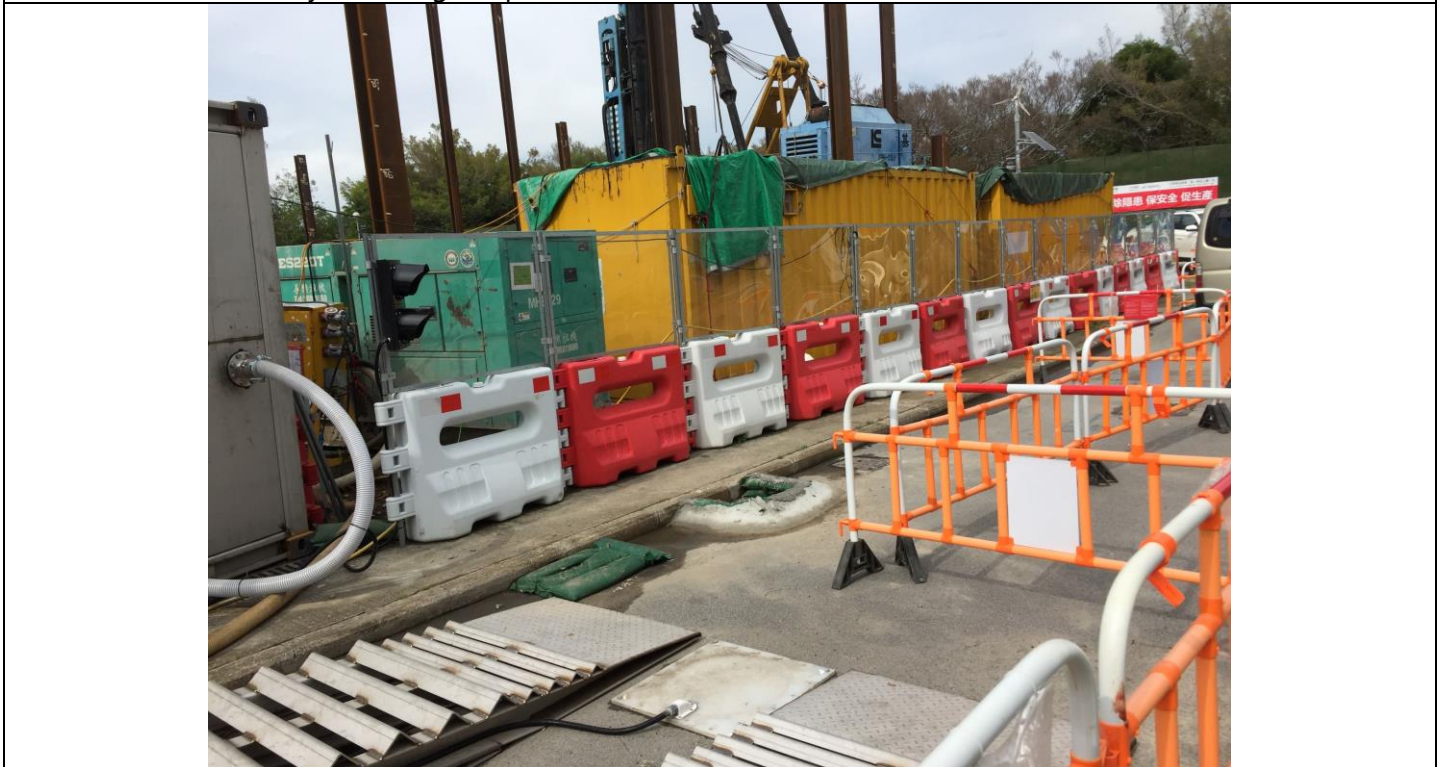
Date of site inspection: 25 May 2021
The surrounding of gullies near the construction site areas were temporarily sealed.

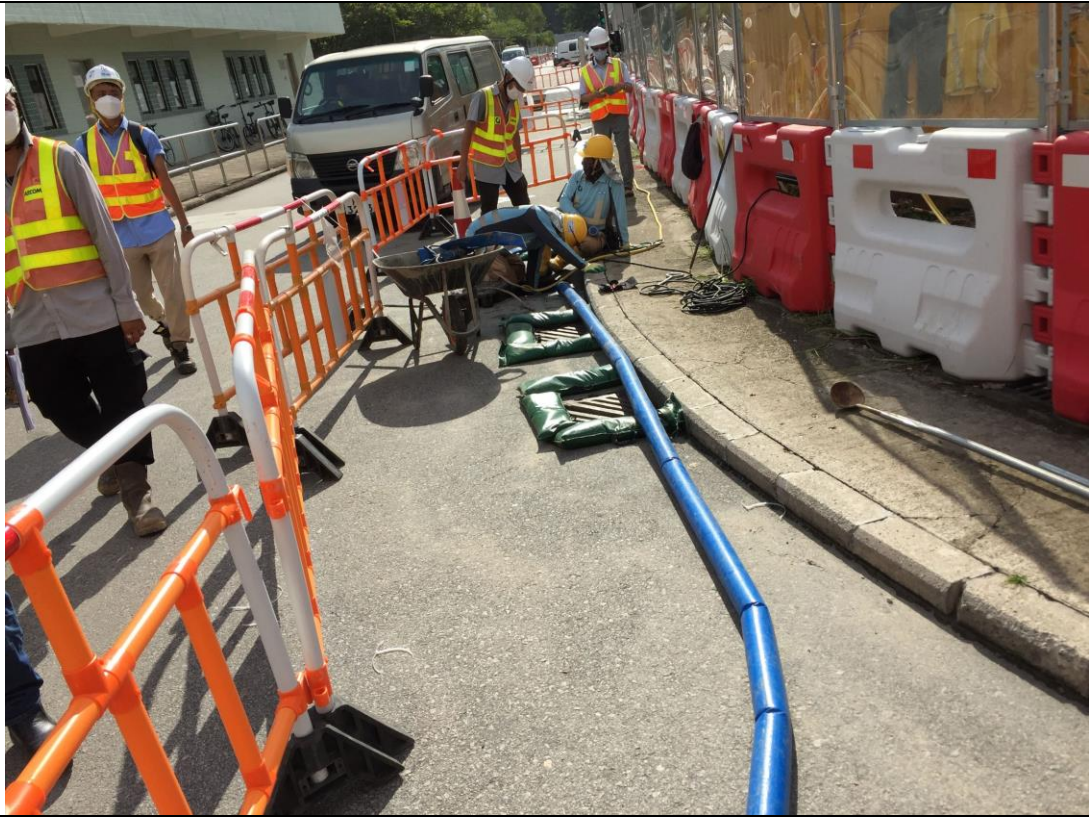
Date of site inspection: 25 May 2021

Manholes were maintained to remove the deposited silt after the rainstorm to prevent overflows.

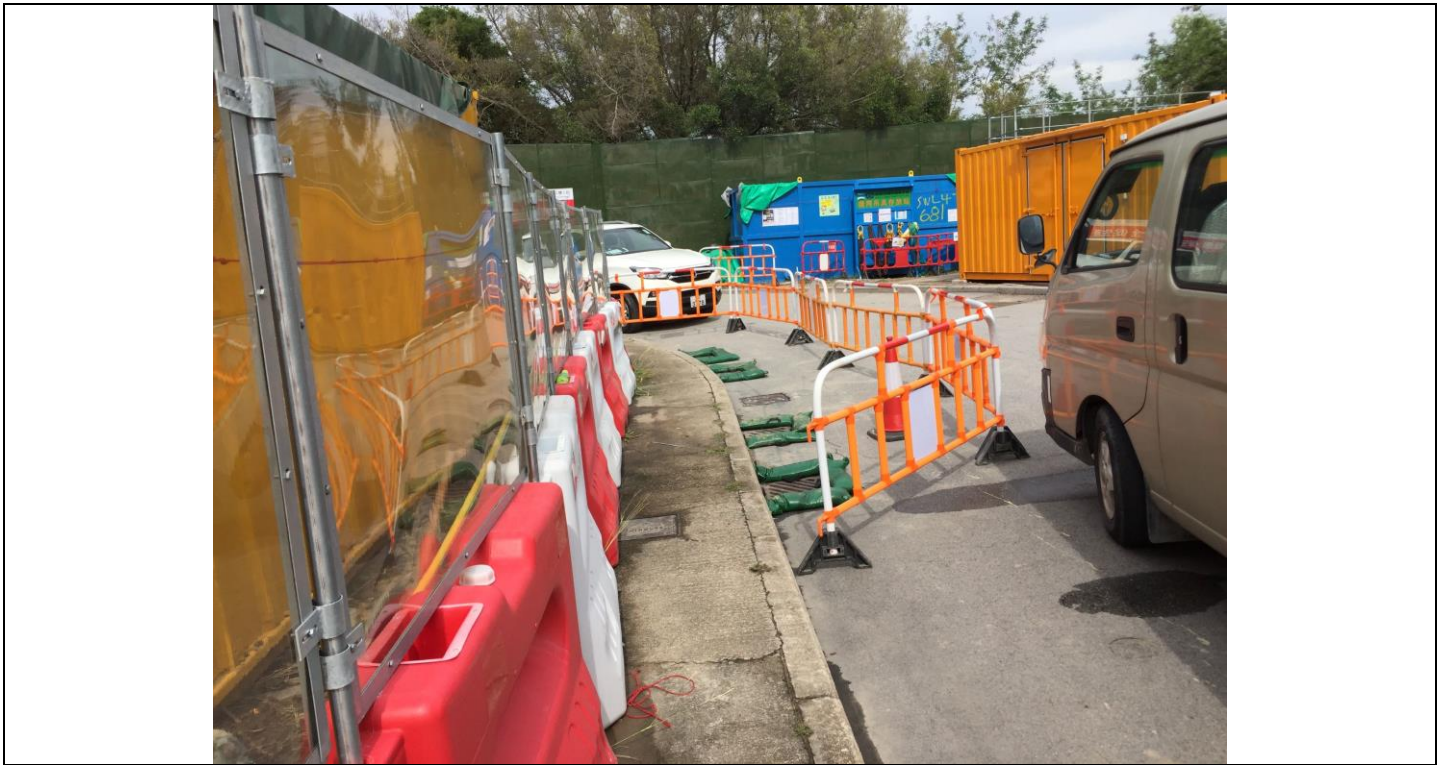
Date of site inspection: 25 May 2021
Gullies were bunded by sand bags to prevent surface runoff.

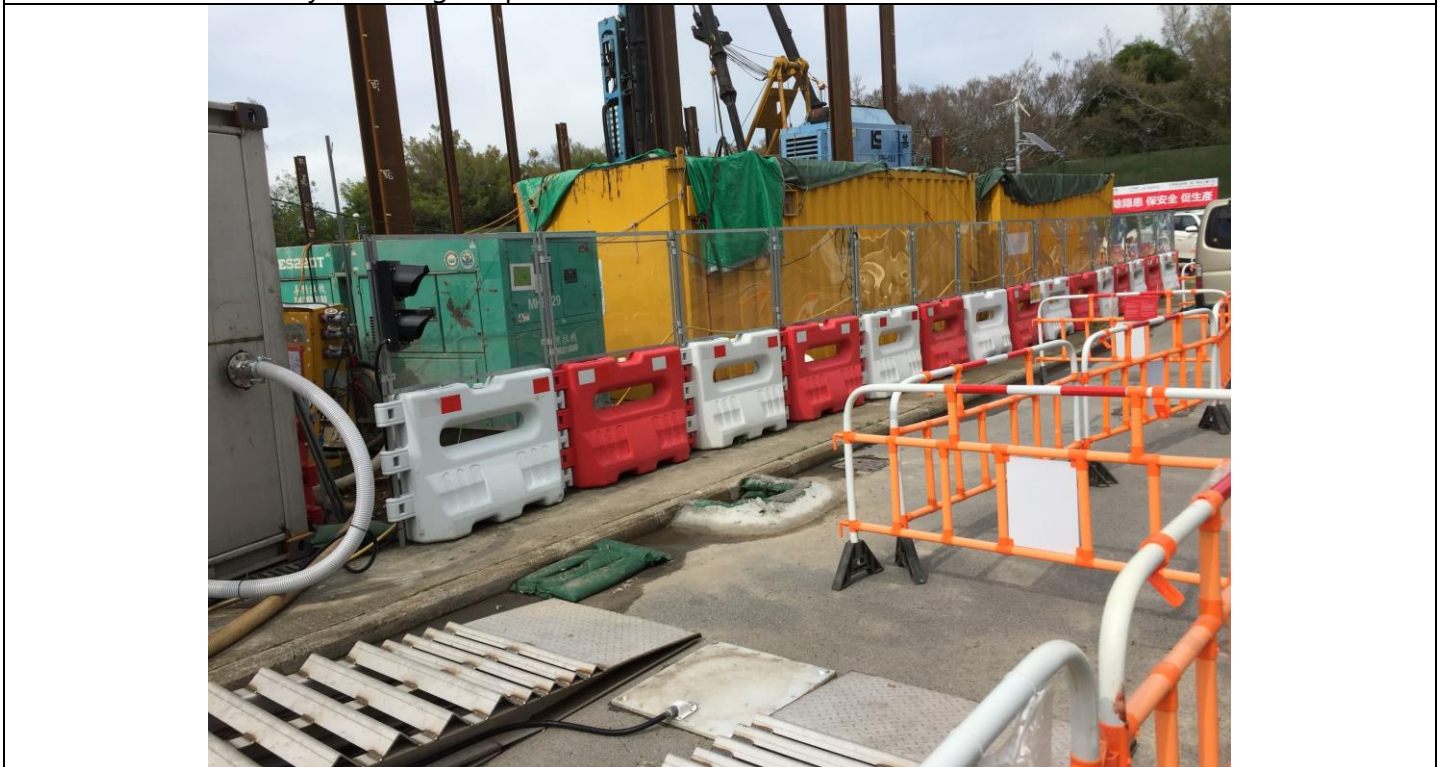
Date of site inspection: 25 May 2021
The surrounding of gullies near the construction site areas were temporarily sealed.

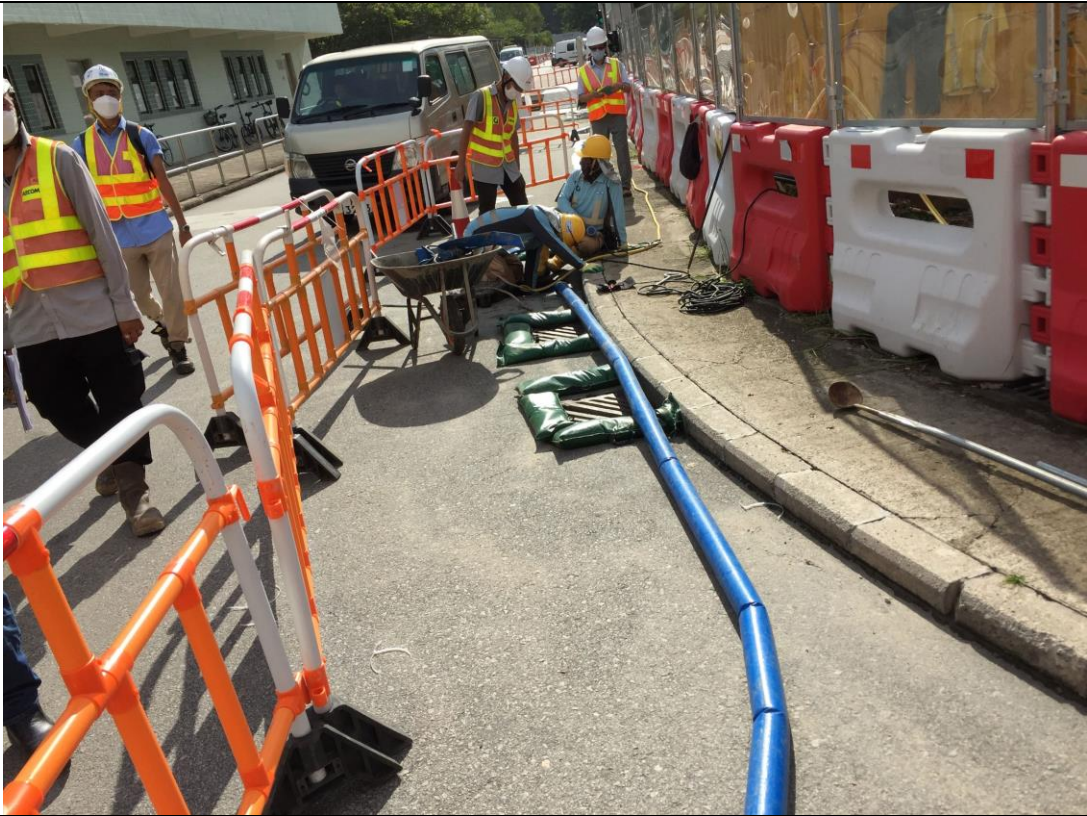
Date of site inspection: 25 May 2021

Manholes were maintained to remove the deposited silt after the rainstorm to prevent overflows.

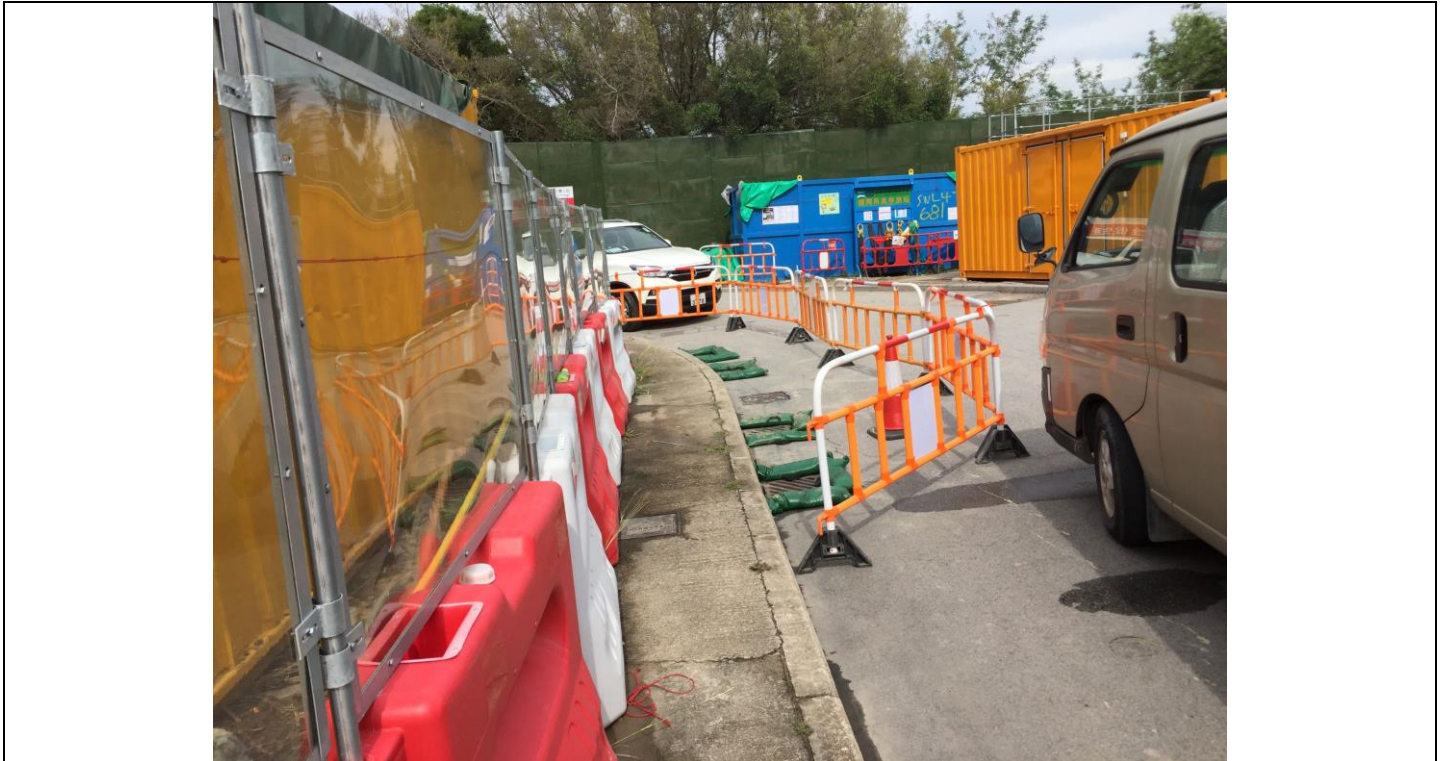
Date of site inspection: 25 May 2021
Gullies were bunded by sand bags to prevent surface runoff.

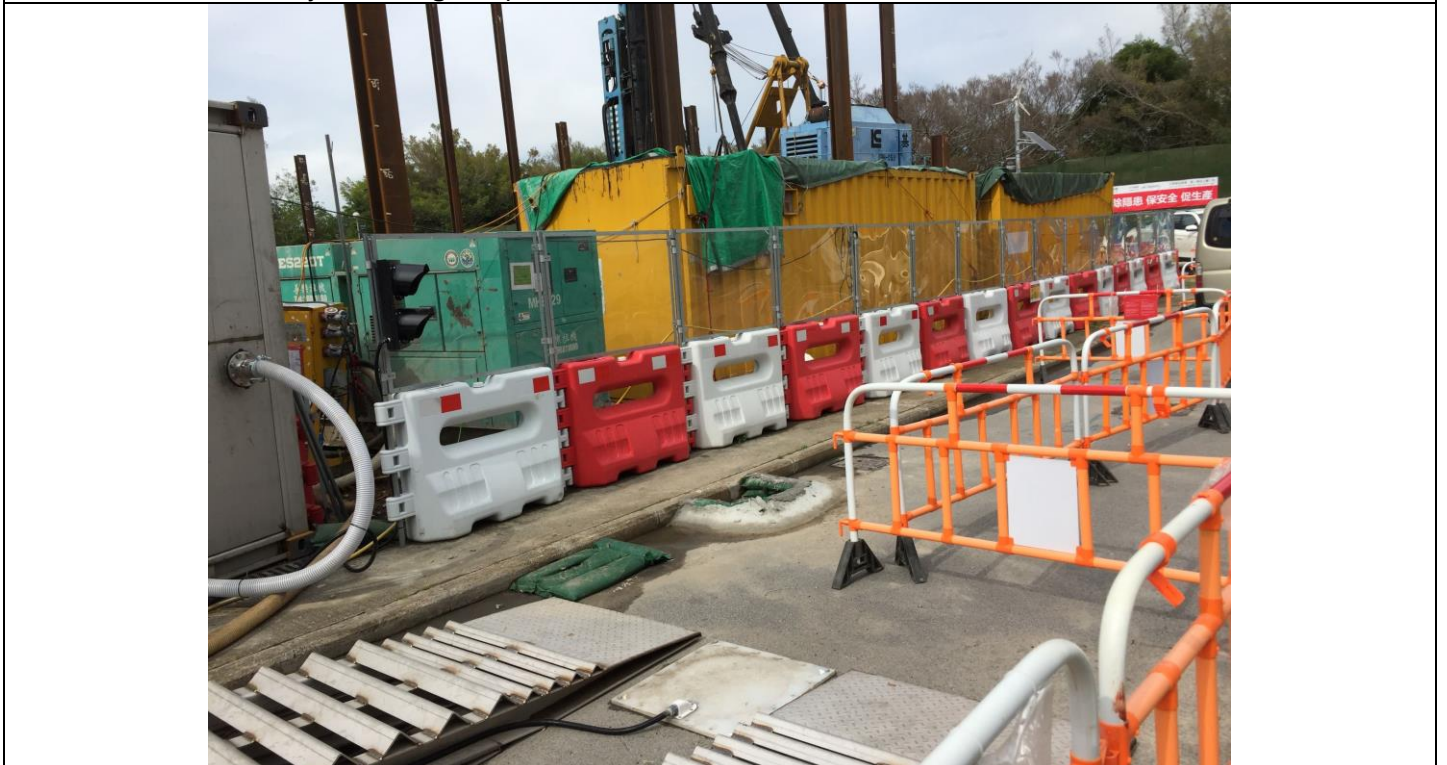
Date of site inspection: 25 May 2021
The surrounding of gullies near the construction site areas were temporarily sealed.

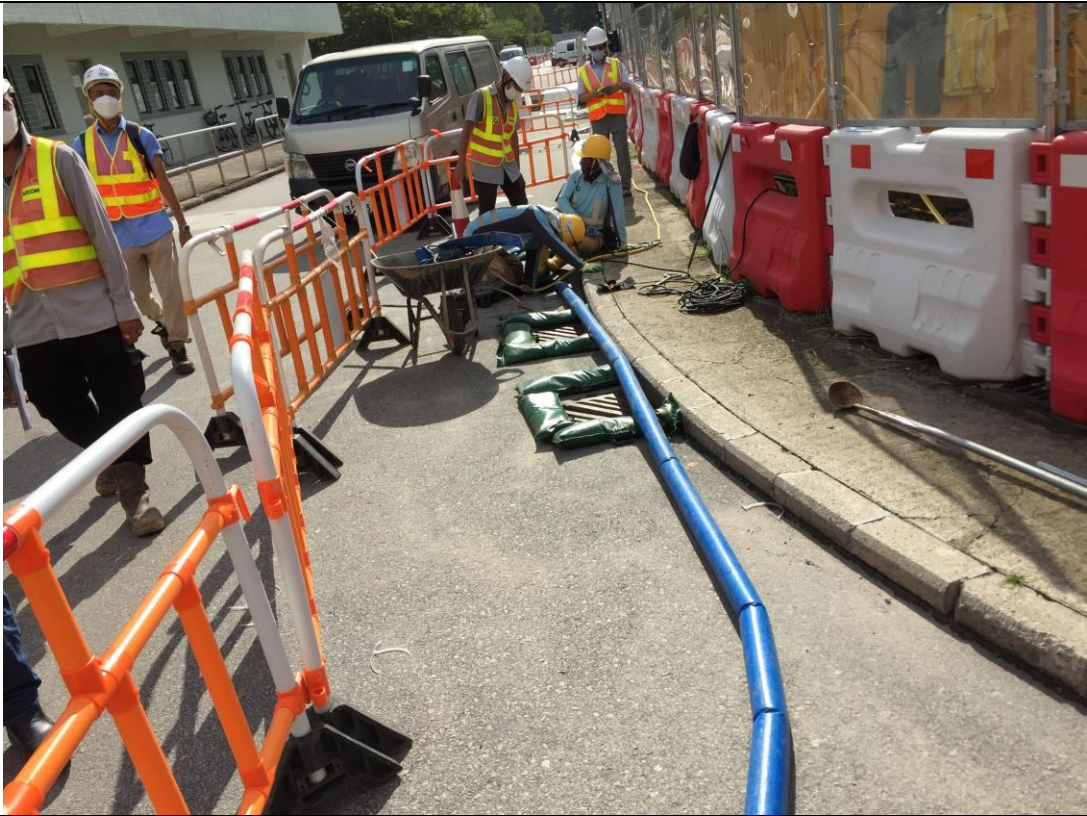
Date of site inspection: 25 May 2021

Manholes were maintained to remove the deposited silt after the rainstorm to prevent overflows.
