Notification of Water Quality Monitoring Exceedance

Incident Report on Action/ Limit Level Exceedance

Reference No.:	IR20210413_M3_SS						
Project:	Contract No. SPW 07/2020 Environmental Team for Construction of Yuen Long Effluent Polishing Plant Stage 1						
Date:	2021/04/13						
Time: (hh:mm)	M1: M2: M3: <u>9:00</u> (Flood Tide)						
Action level / Limit level:		DO (mg/L)		Turbidity (NTU)		SS (mg/L)	
		AL	LL	AL	LL	AL	LL
	M1	2.25	1.91	48.4	50.4	59.0	68.0
	M2	1.88	1.79	43.0	52.4	81.0	112.0
	M3	3.28	3.14	74.3	78.0	104.0	167.0
Measured level of exceeded parameter: (fill in / circle as appropriate)	M1	DO (AL / LL) : _____		M3	DO (AL / LL) : _____		
		NTU (AL / LL) : _____			NTU (AL / LL) : _____		
		SS (AL / LL) : _____			SS (AL / LL) : <u>125</u>		
	M2	DO (AL / LL) : _____					
		NTU (AL / LL) : _____					
		SS (AL / LL) : _____					
Action taken / to be taken: (tick / circle / fill in as appropriate)	Inspection :						
	<input checked="" type="checkbox"/> ER / IEC / Contractor is/are informed. <input checked="" type="checkbox"/> Monitoring equipment & monitoring data are checked and confirmed without problem. <input type="checkbox"/> In-situ measurement is repeated. <input typ

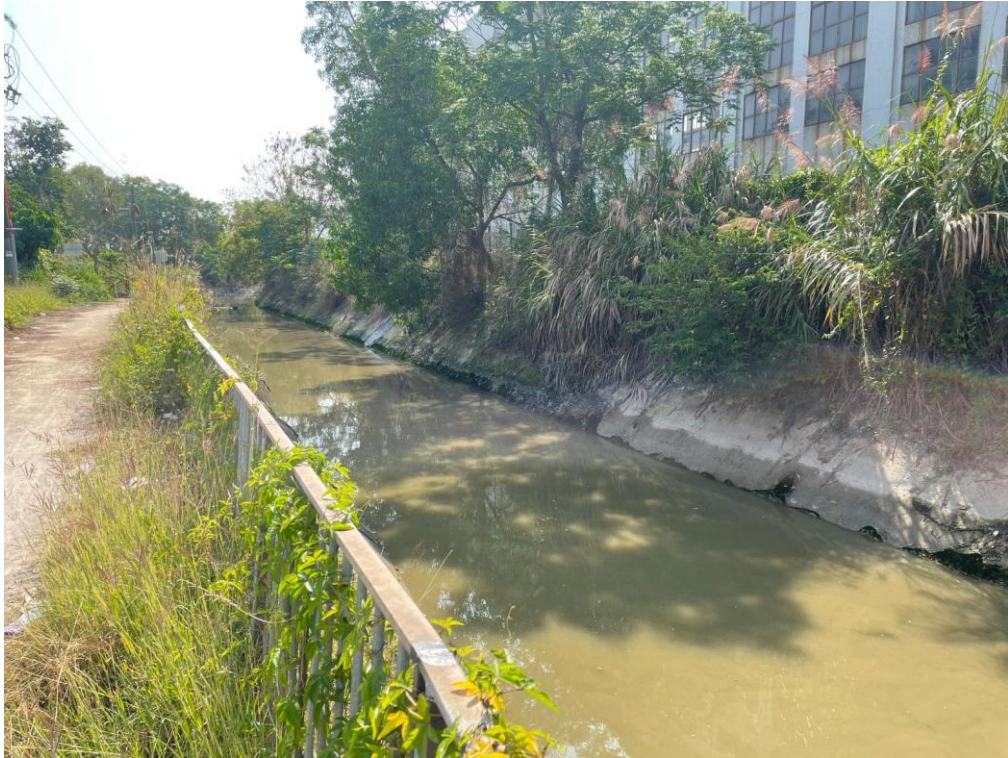
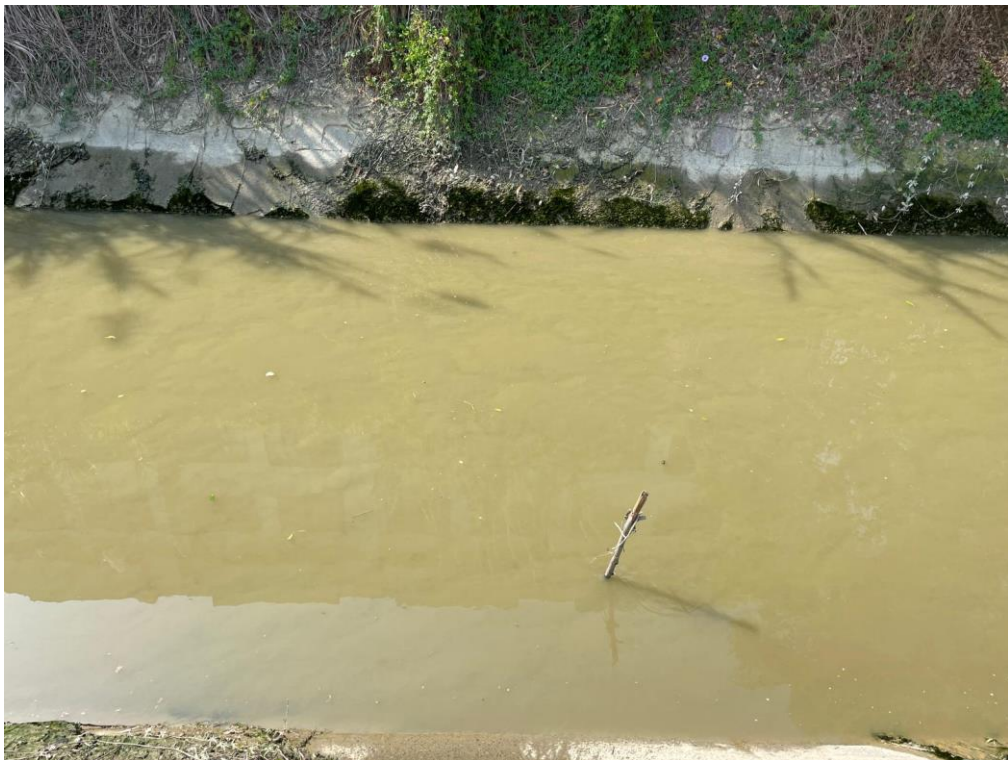
Date of investigation: 13 April 2021 (Flood Tide)
Monitoring Station: M3

Reference No.:	IR20210413_M3_SS			
Project:	Contract No. SPW 07/2020 Environmental Team for Construction of Yuen Long Effluent Polishing Plant Stage 1			
Date:	2021/04/13			
Conclusion:	<input checked="" type="checkbox"/>	DO	Turbidity	SS
	Due to change or/and influences of ambient condition in the vicinity, not Project related			M3
Mitigation Measures:	<input type="checkbox"/> Due to influences of construction activities under this project in the vicinity, considered to be Project related			
	<p>The following mitigation measures have been taken:</p> <ol style="list-style-type: none"> 1. Channels, earth bunds or sand bag barriers were provided on site to properly direct stormwater to such silt removal facilities; 2. The surfaces of construction site areas near the drainages were paved; 3. Construction materials on sites were covered with tarpaulin or similar fabric during rainstorms; and 4. Manholes were adequately covered and temporarily sealed so as to prevent silt, construction materials or debris from getting into the drainage system.

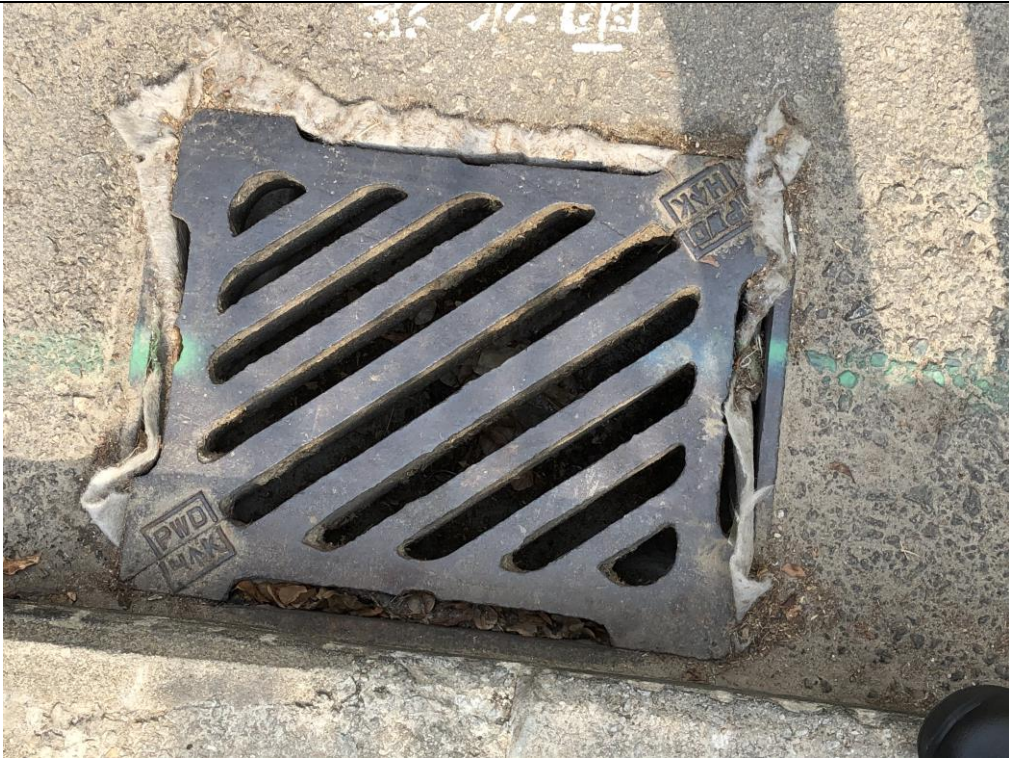
Date of site inspection: 7 April 2021

Gullies were covered by geotextiles and banded to prevent surface runoff.

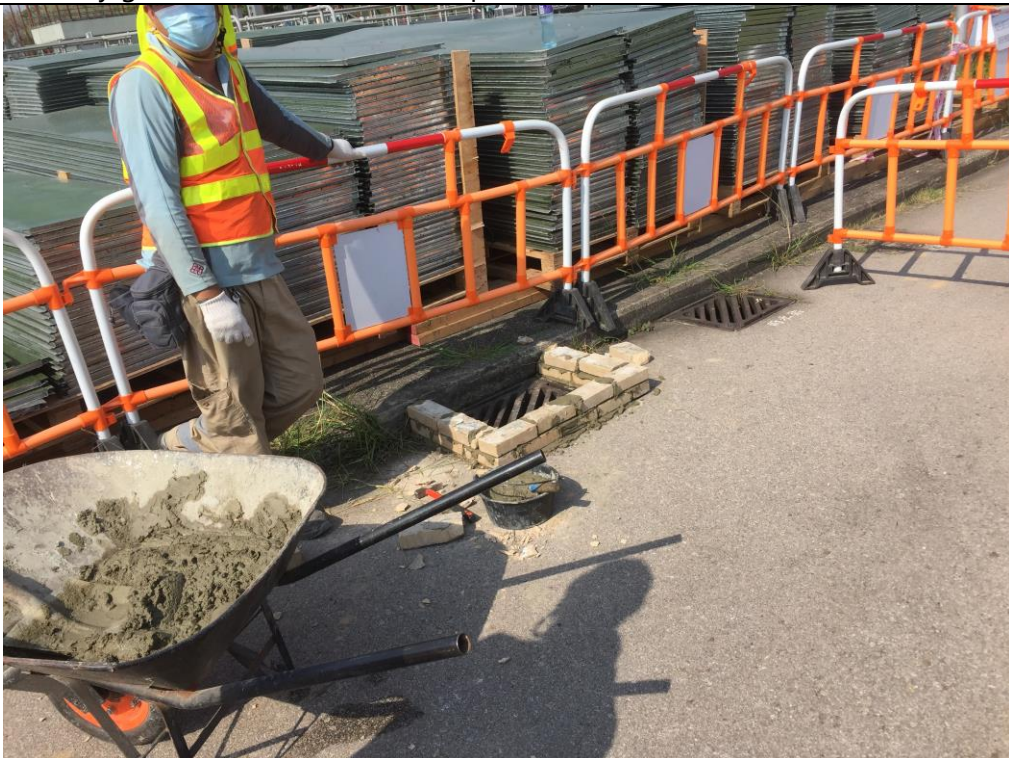
Date of site inspection: 21 April 2021

The drainages near the construction site areas were temporarily sealed.
