Air Quality Monitoring Results

Contract No. SPW 02/2023

Environmental Team for Construction of Yuen long

Effluent Polishing Plant Stage 1

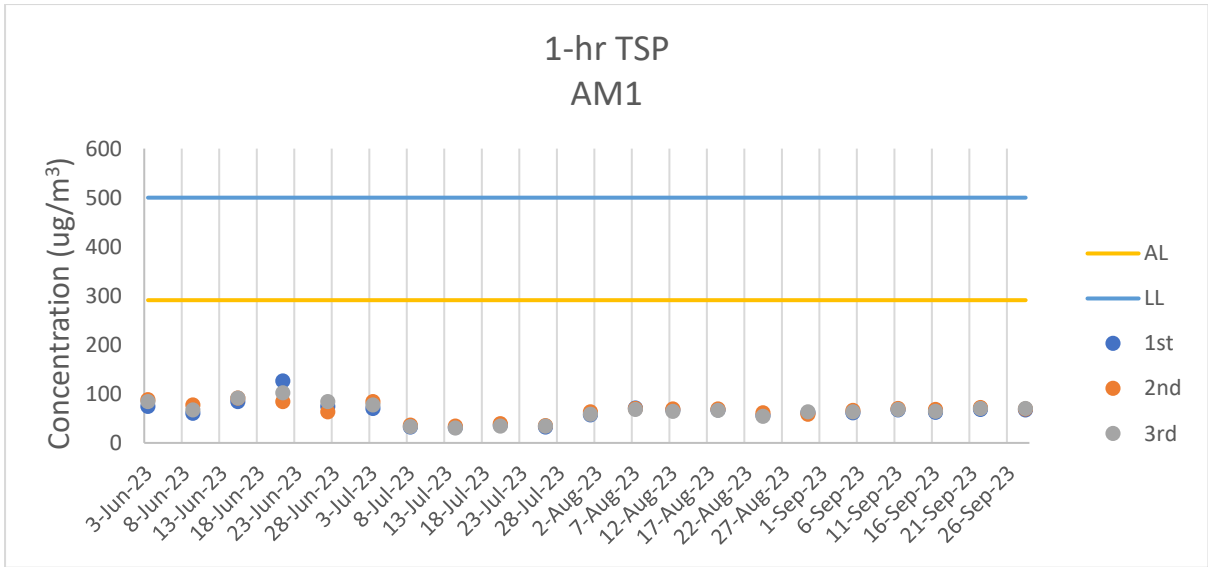
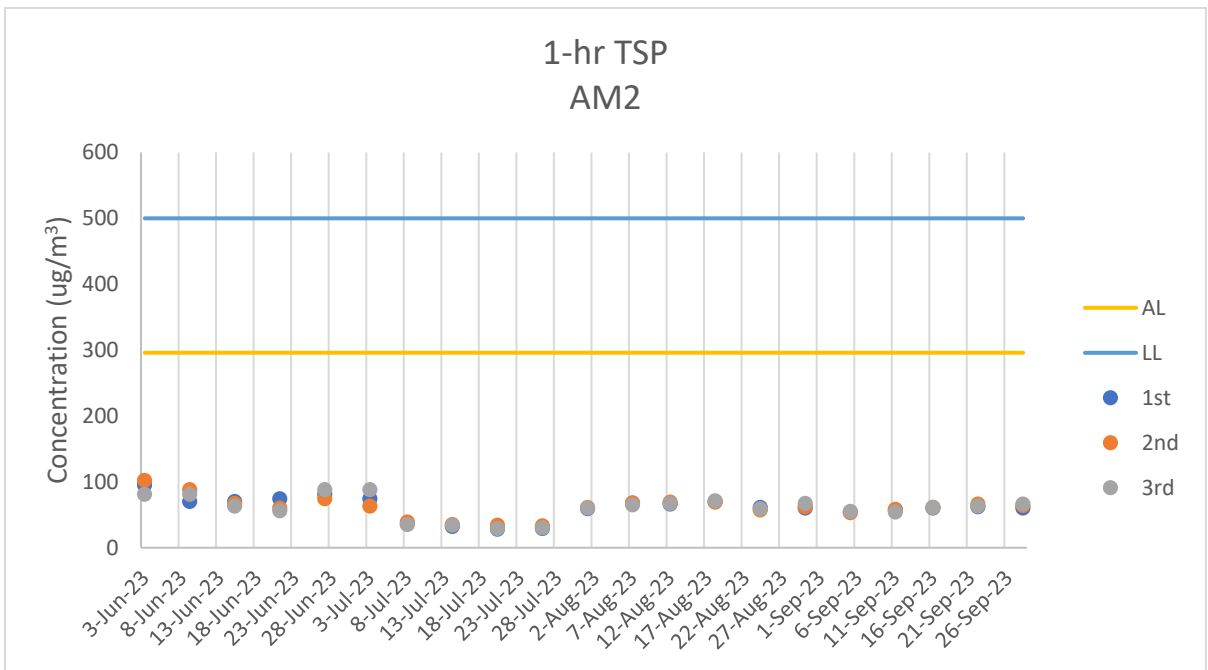
Air Quality Monitoring Results

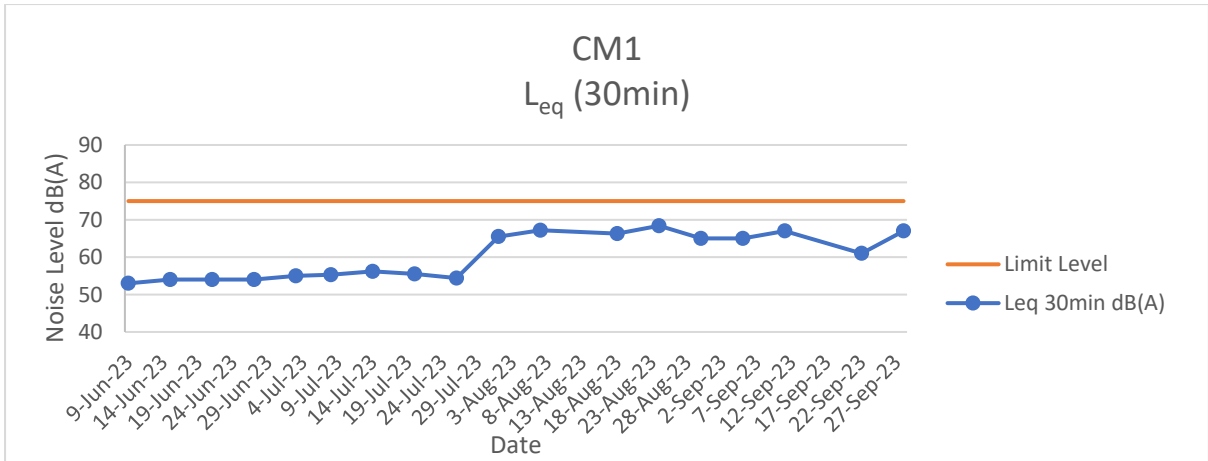
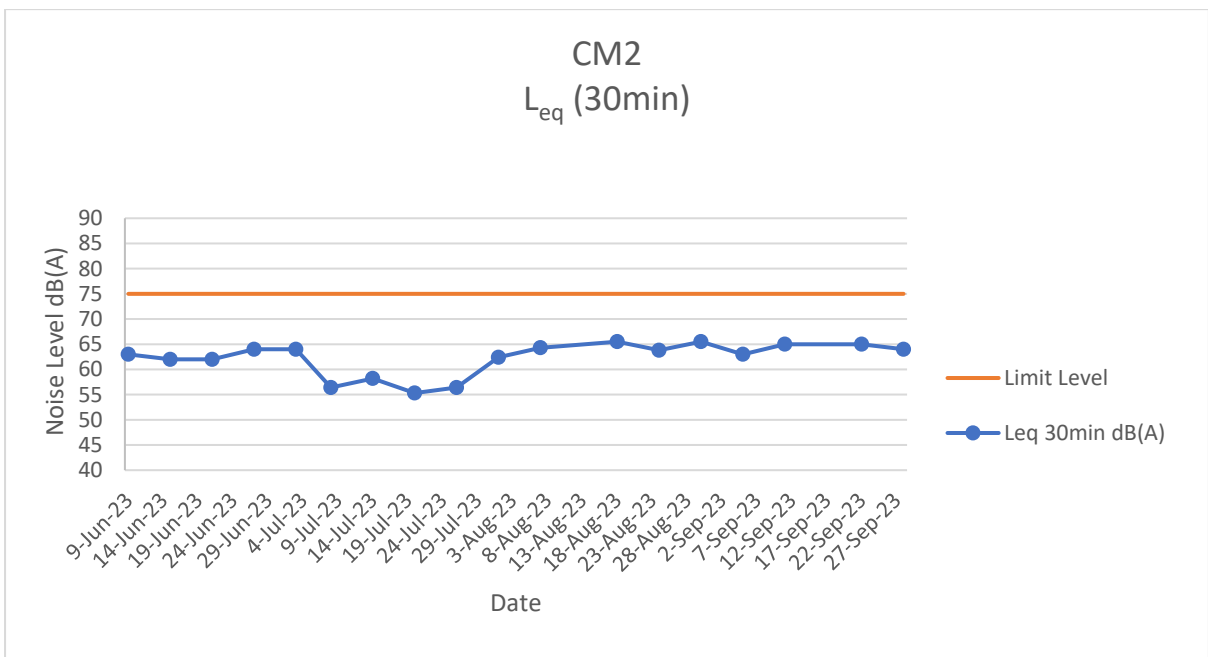
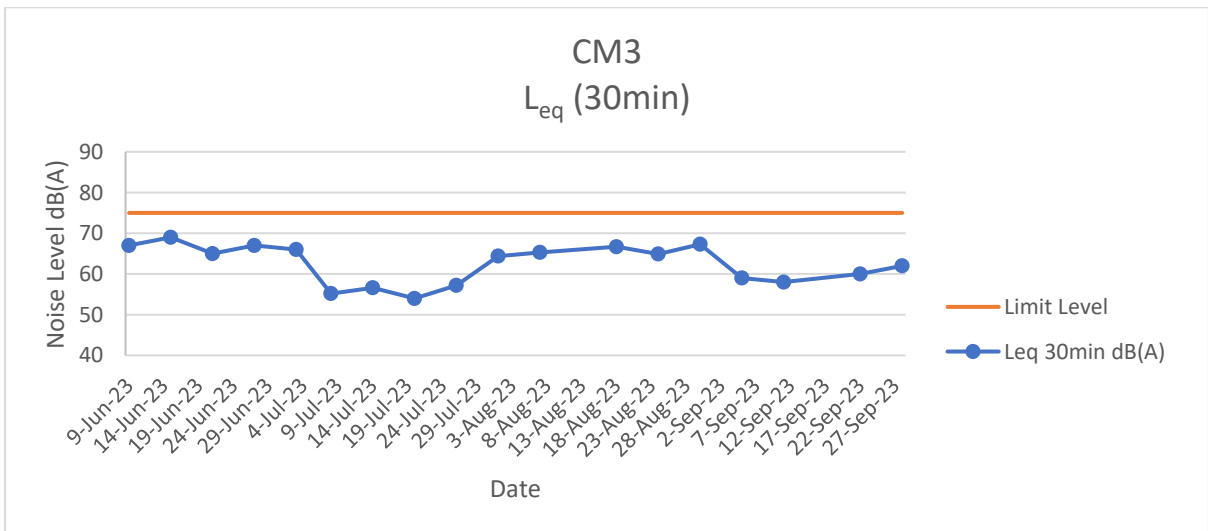
Noise Monitoring Results

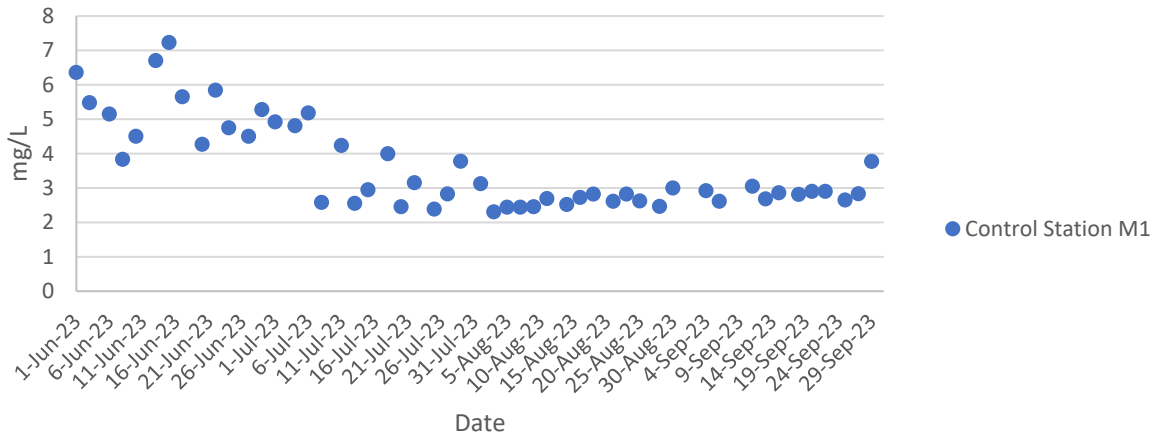
Dissolved Oxygen at Mid-Flood Tide

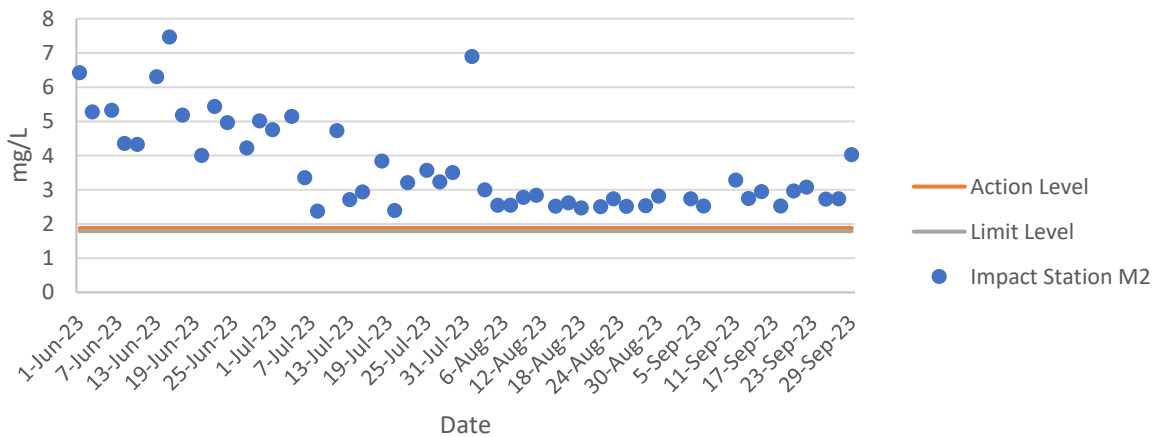
Dissolved Oxygen at Mid-Flood Tide

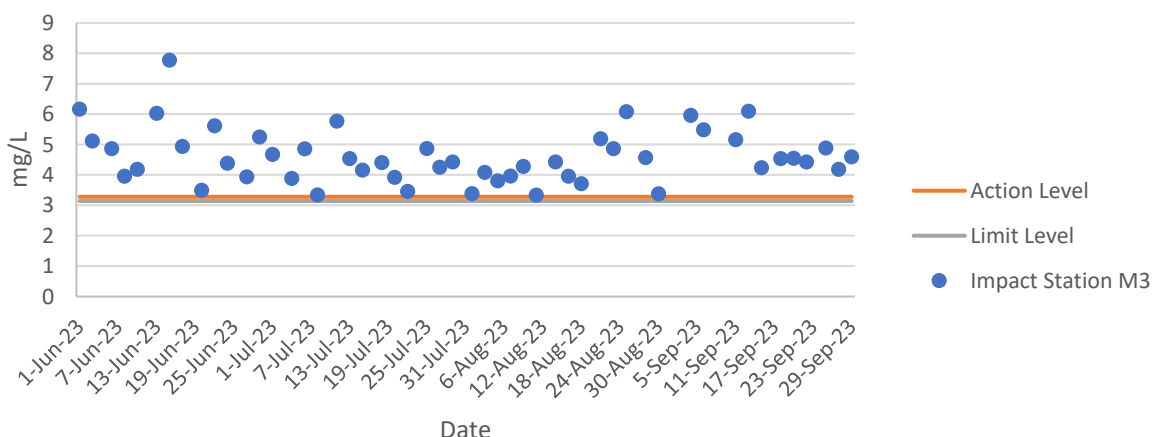
Dissolved Oxygen at Mid-Flood Tide

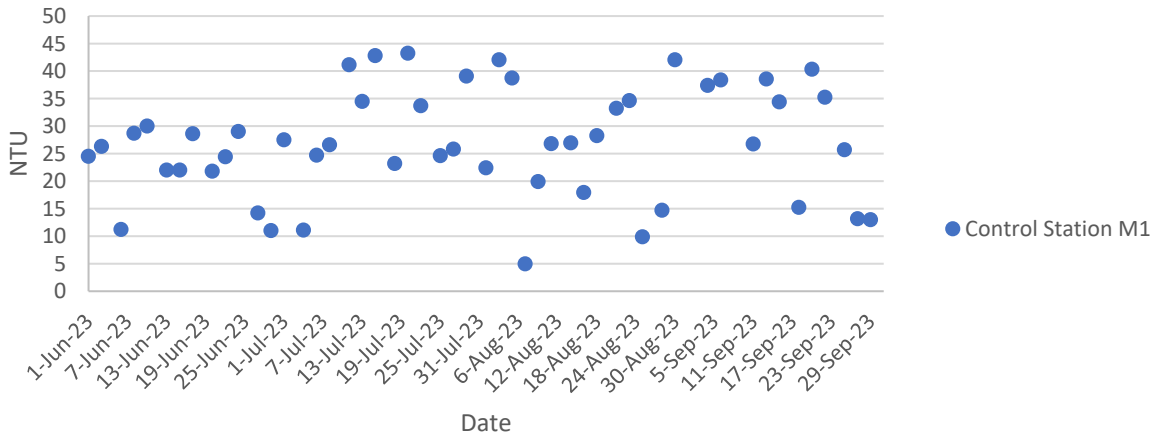
Turbidity at Mid-Flood Tide

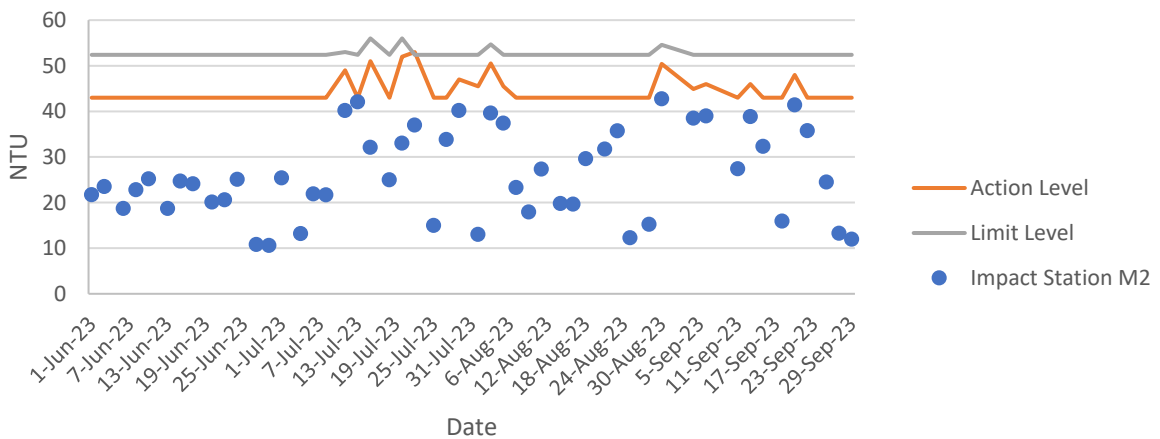
Turbidity at Mid-Flood Tide

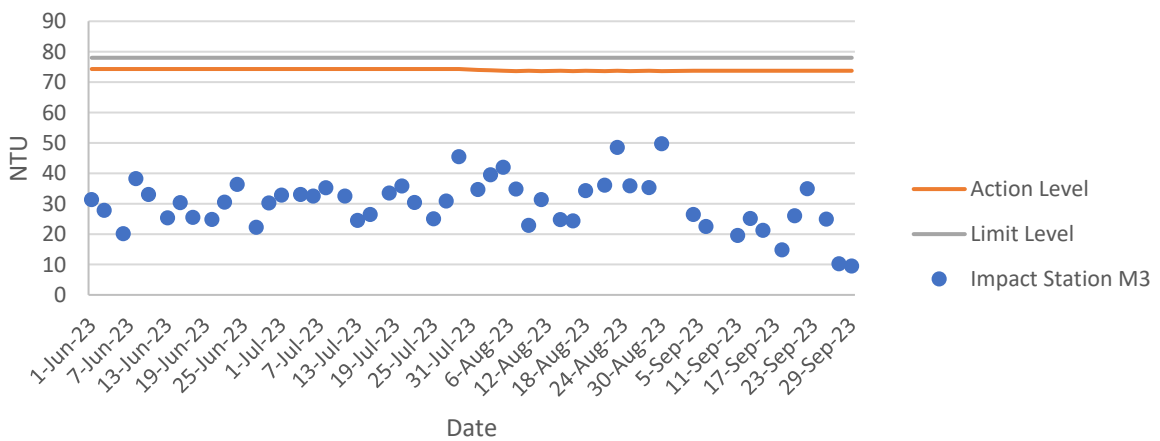
Turbidity at Mid-Flood Tide

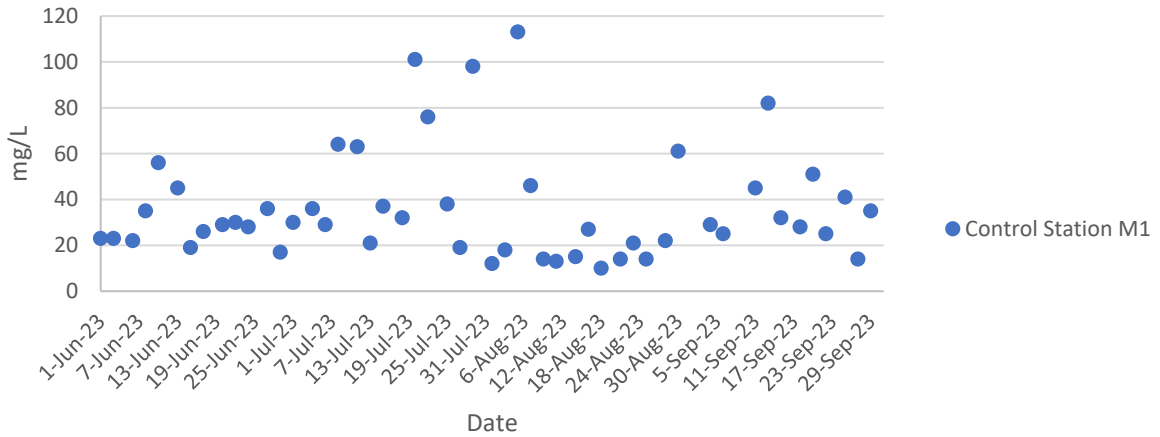
Total Suspended Solids at Mid-Flood Tide

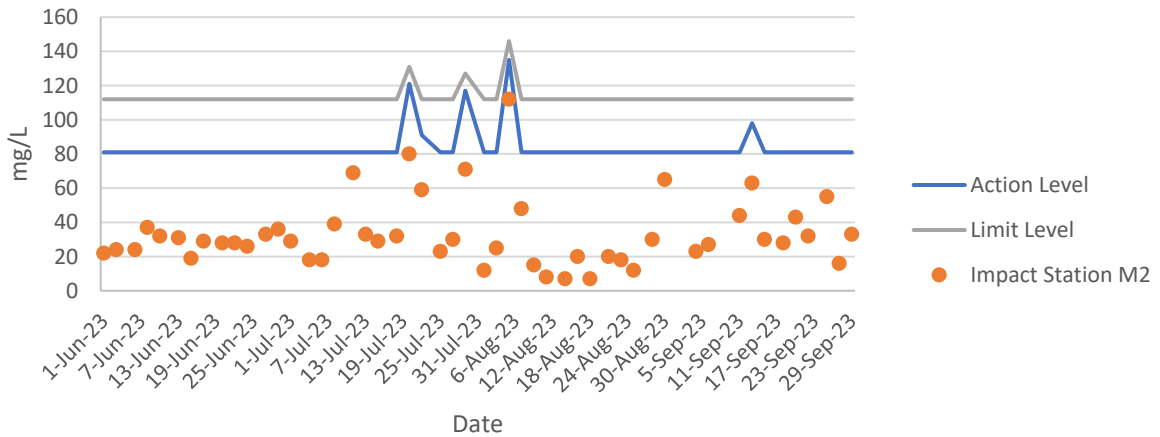
Total Suspended Solids at Mid-Flood Tide

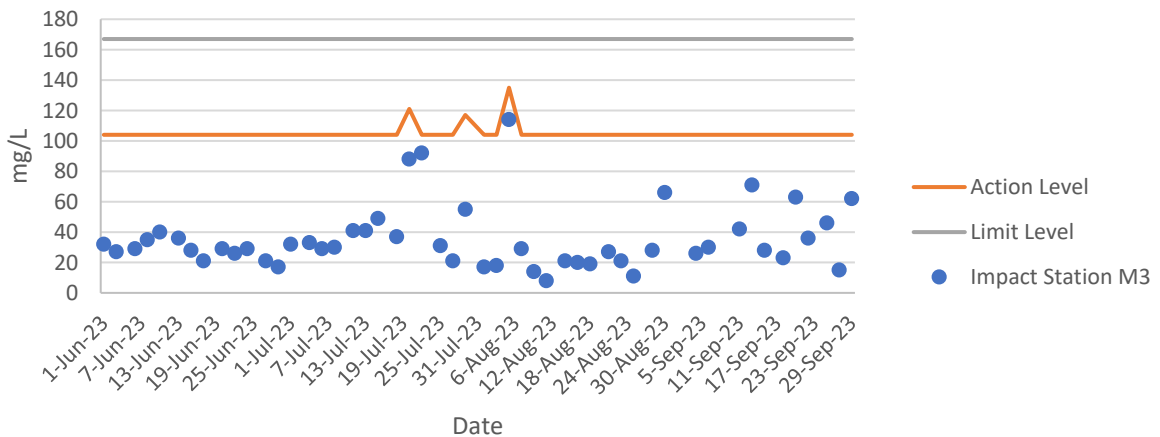
Total Suspended Solids at Mid-Flood Tide

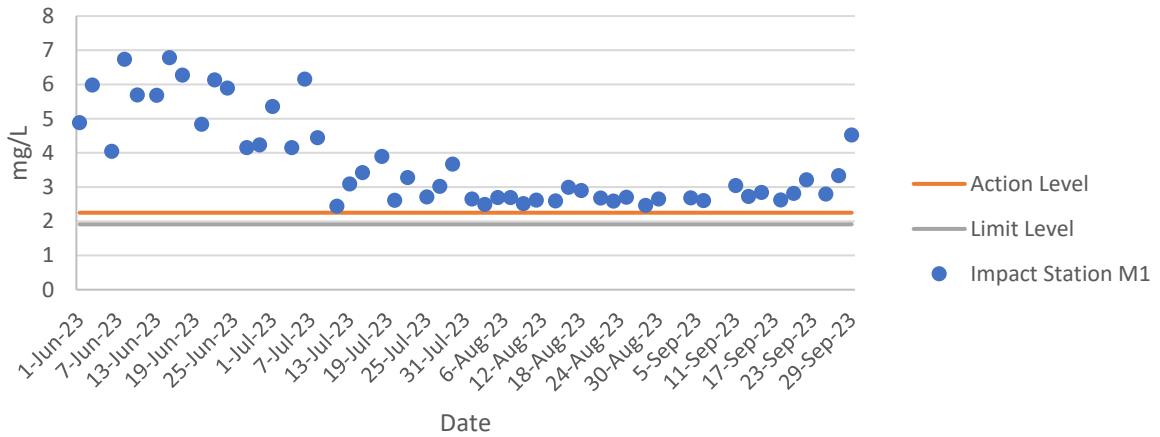
Dissolved Oxygen at Mid-Ebb Tide

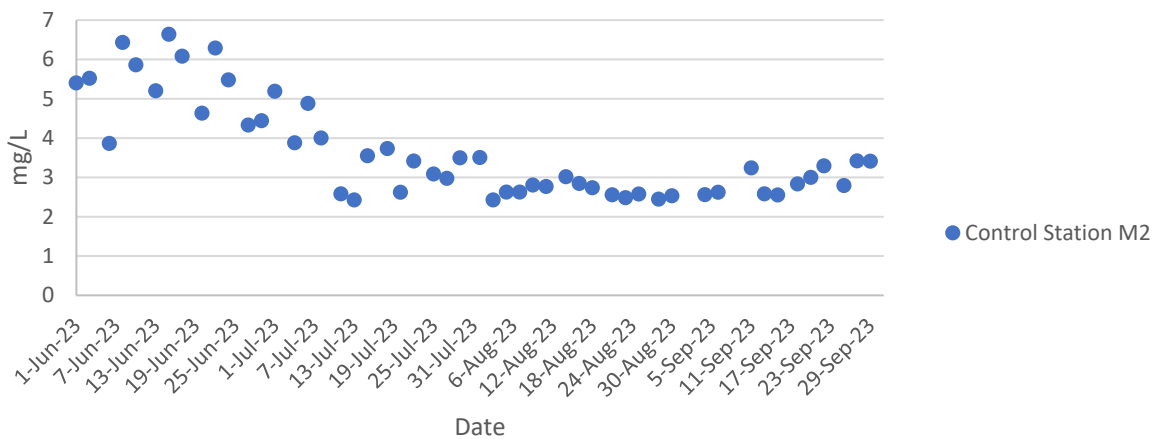
Dissolved Oxygen at Mid-Ebb Tide

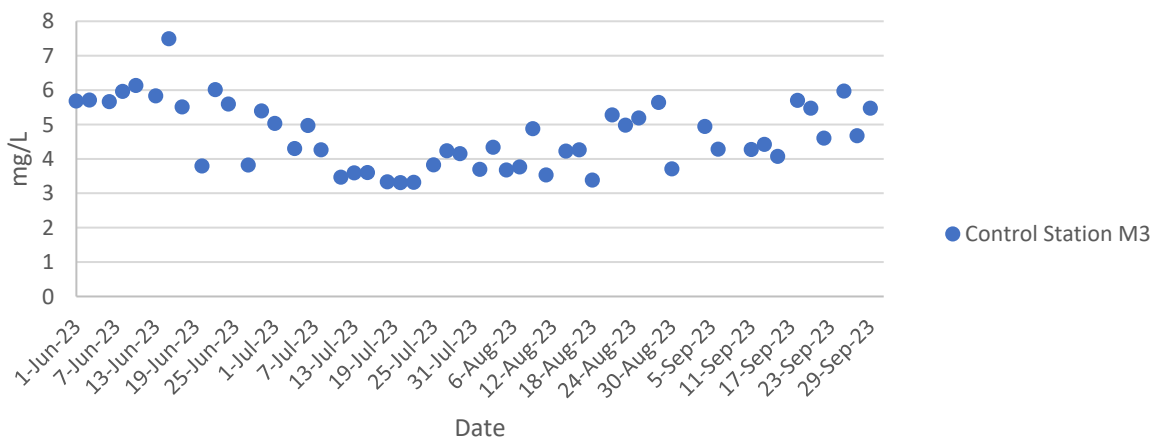
Dissolved Oxygen at Mid-Ebb Tide

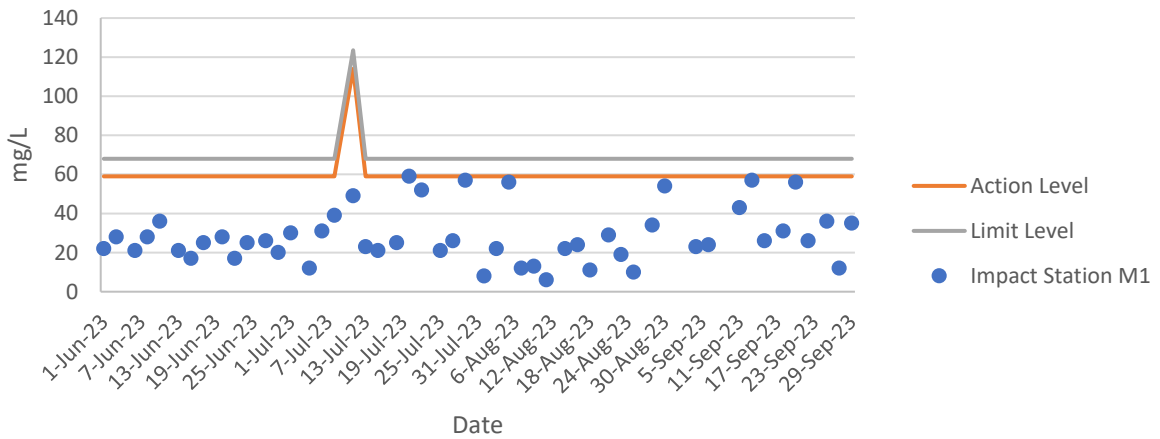
Total Suspended Solids at Mid-Ebb Tide

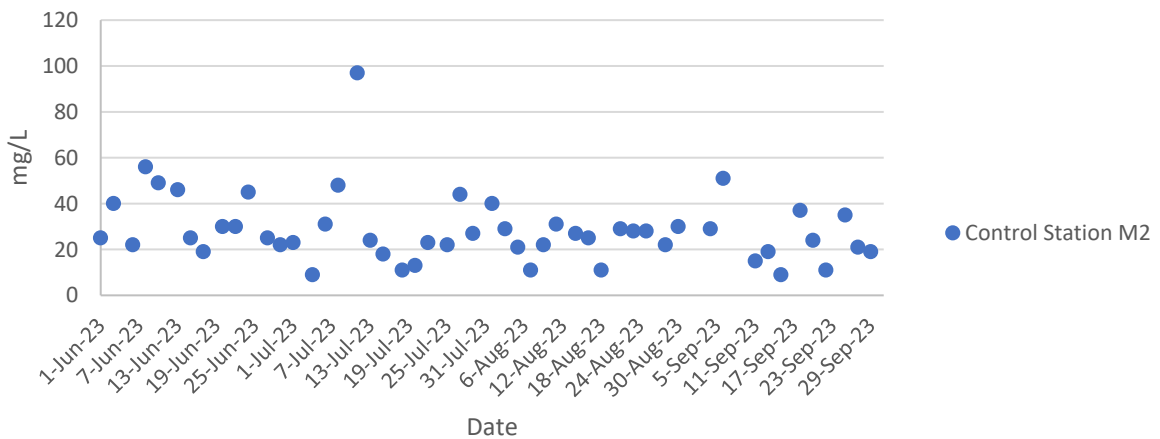
Total Suspended Solids at Mid-Ebb Tide

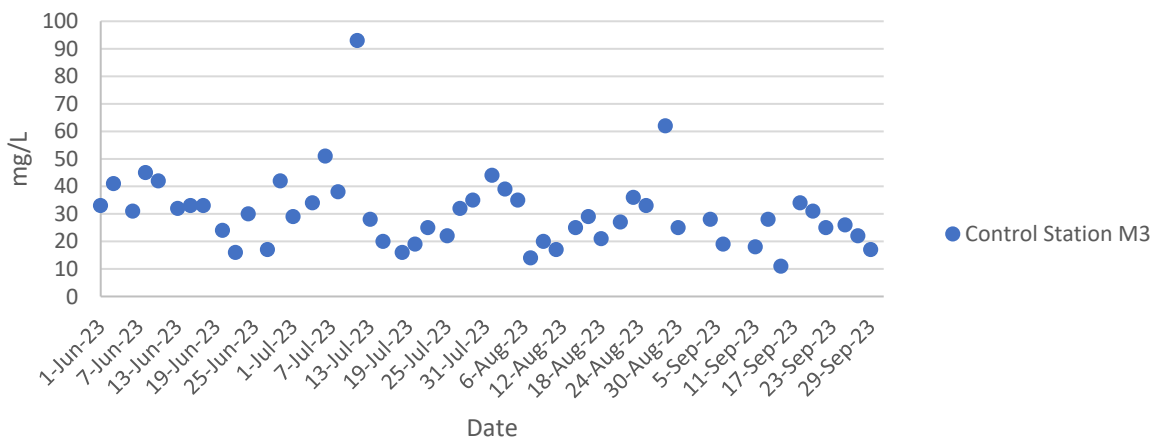
Total Suspended Solids at Mid-Ebb Tide

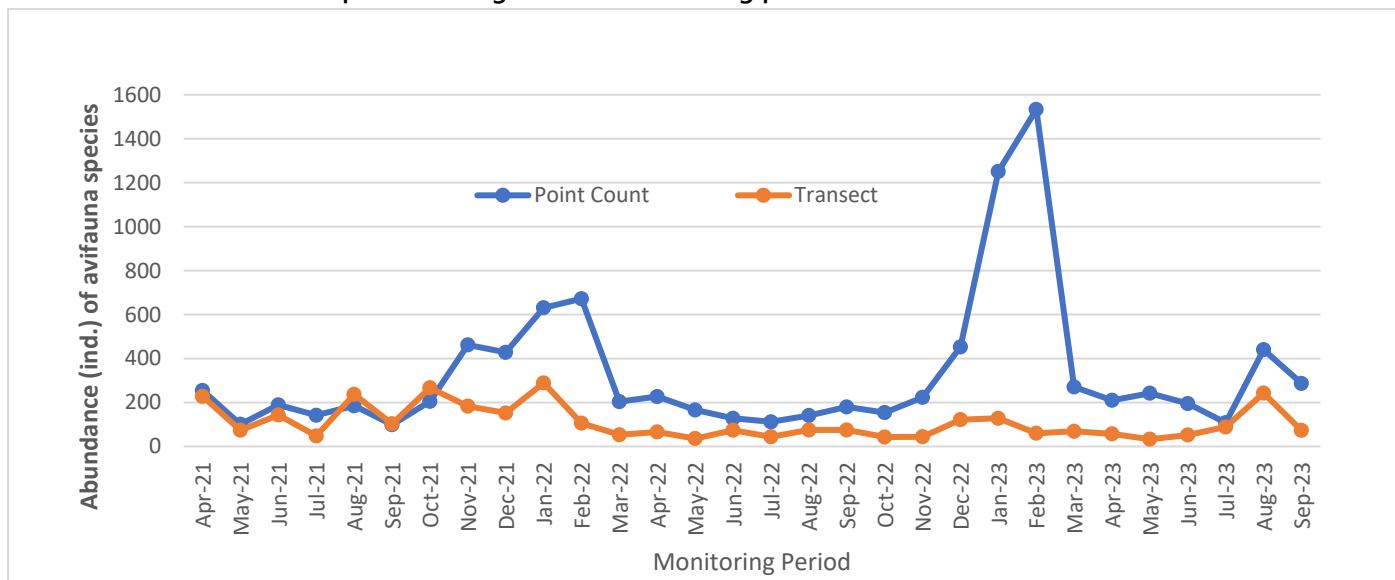
Abundance of all avifauna species throughout the monitoring period

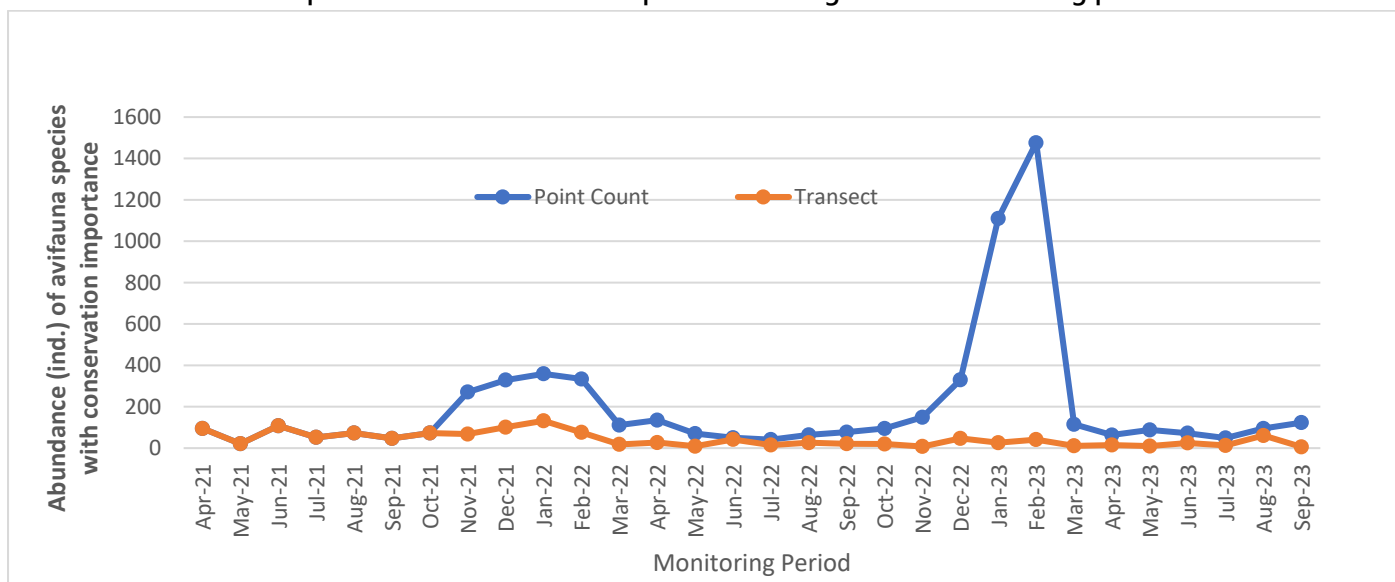
Abundance of avifauna species with conservation importance throughout the monitoring period

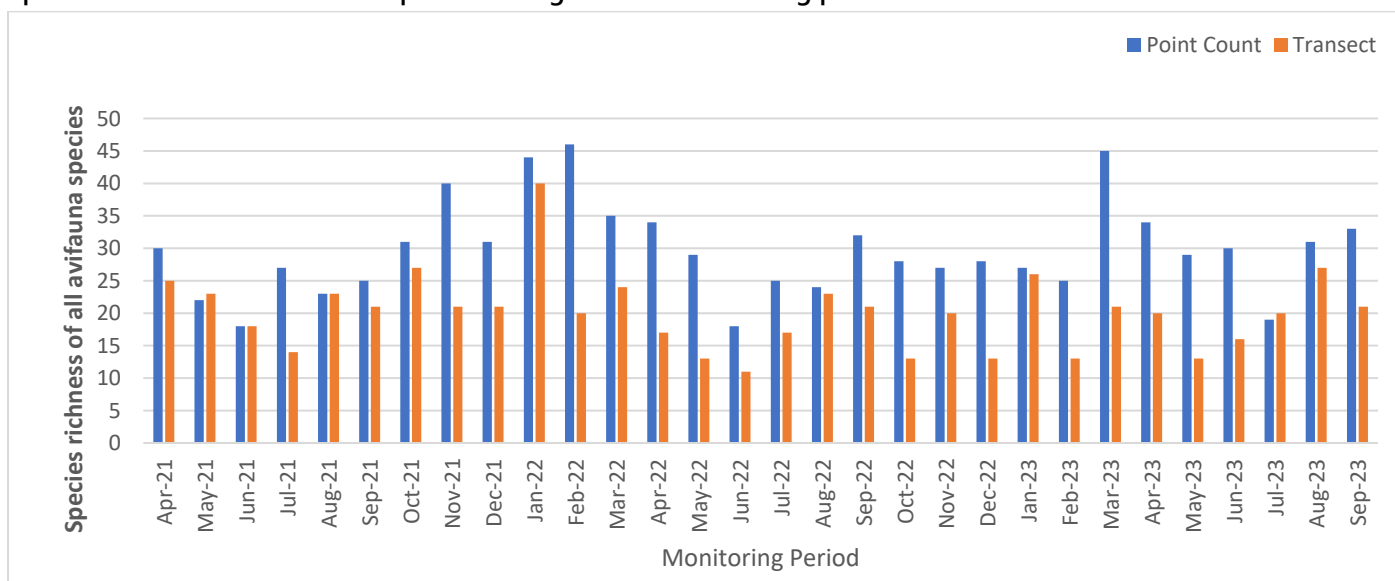
Species richness of all avifauna species throughout the monitoring period

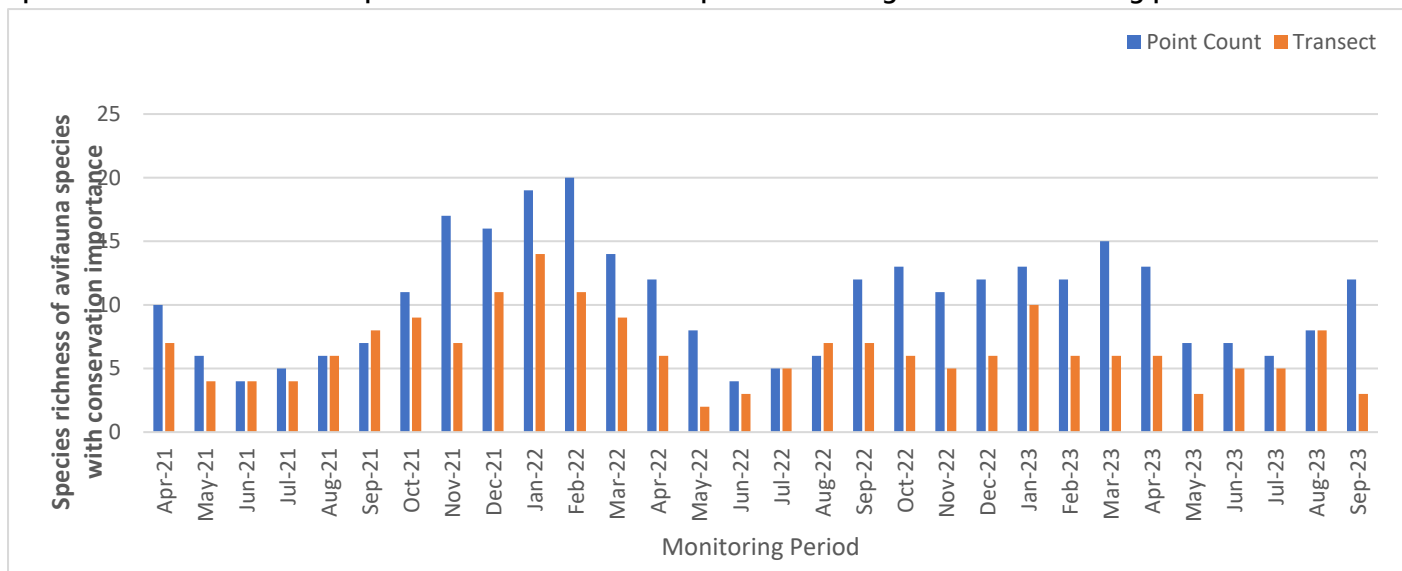
Species richness of avifauna species with conservation importance throughout the monitoring period

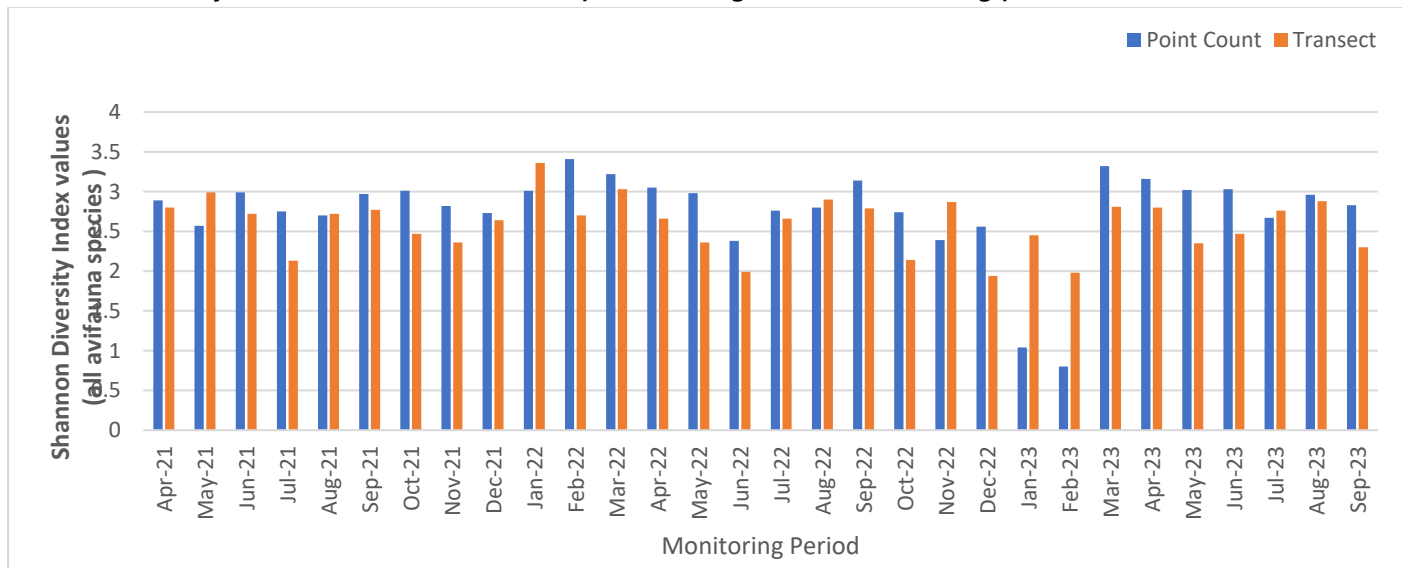
Shannon Diversity Index values of all avifauna species throughout the monitoring period

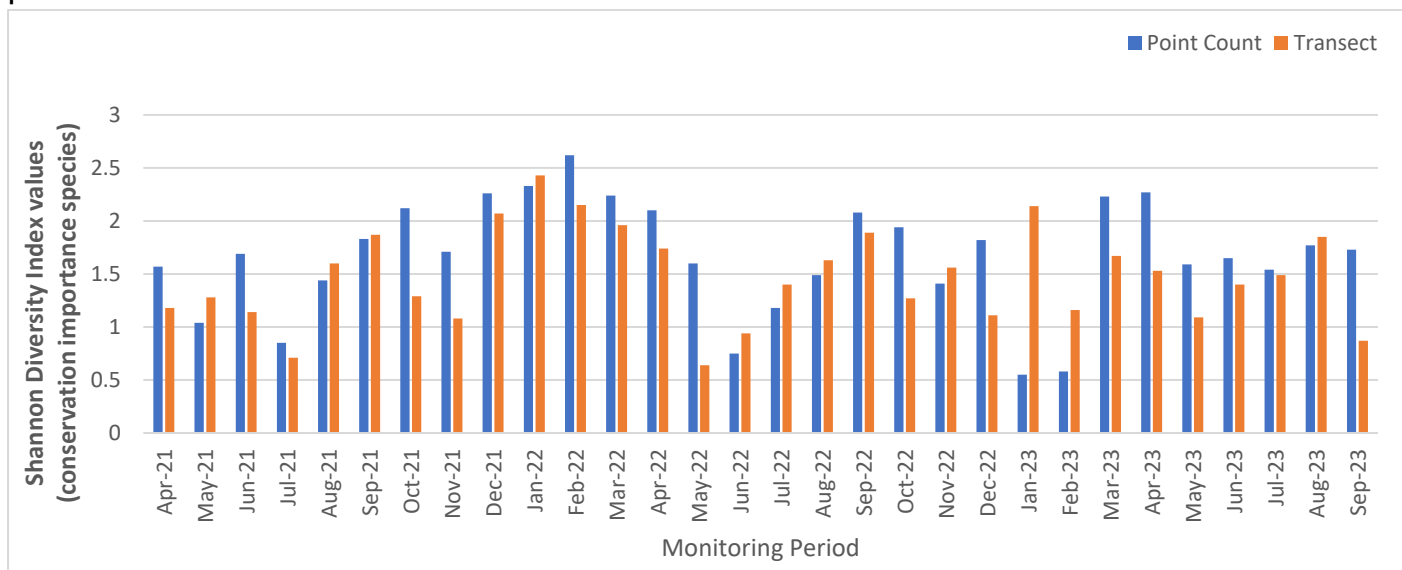
Shannon Diversity Index values of avifauna species with conservation importance throughout the monitoring period
